Environmental Monitoring Report of Manthali - Pakarbas road sub project in Ramechhap District  
Project Number: 30232  
March 2010

## NEP: Decentralized Rural Infrastructure and Livelihoods Project

Environmental Monitoring Report  
of  
**Manthali- Pakarbas Road Sub-Project**

Proponent:  
**District Development Committee, Ramechhap**  
Manthali, Ramechhap

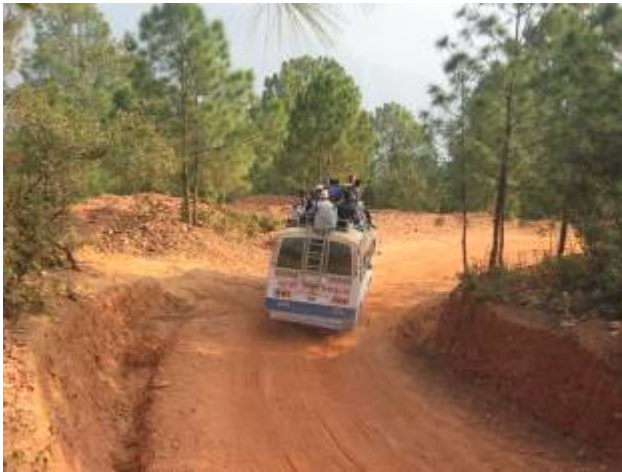
Vehicles plying in Manthali-Pakarbass road

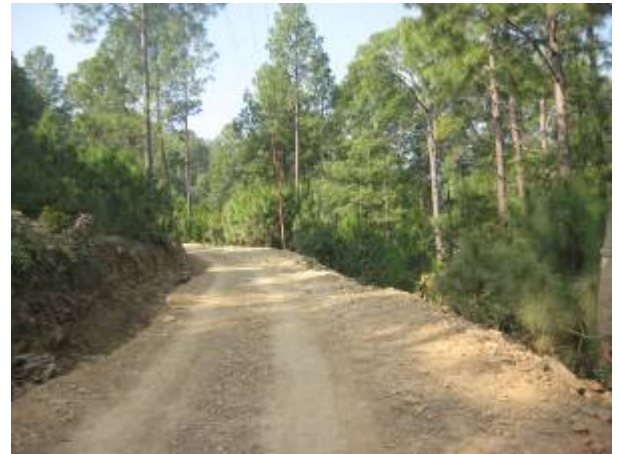
Road passing through community forest

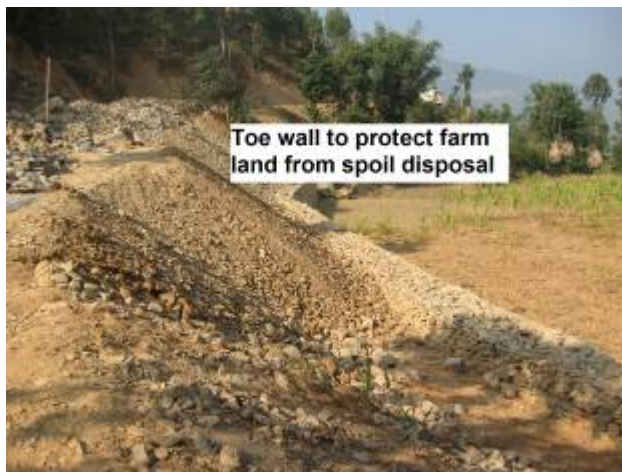
Toe wall constructed at Ch 9+300

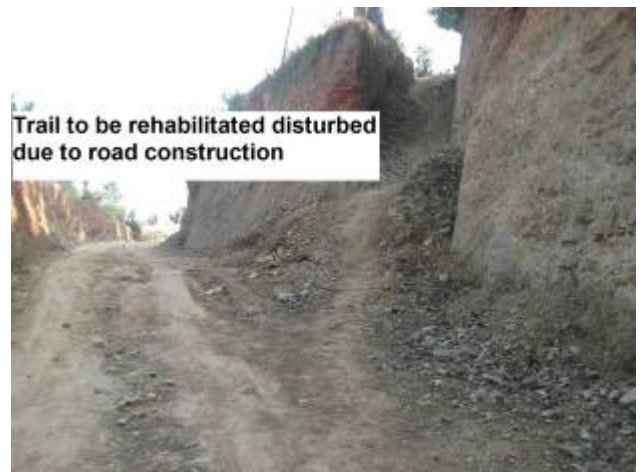
Trail to be rehabilitated at Ch 11+500

6. Most of the community infrastructures affected by the construction of the road have been rehabilitated. However, trails joining the road should be rehabilitated to have easy access to the rural people at Ch 9+800, 11+500 and 11+550.
