Technical Audit Final Report
(Loan 2140-AFG: Andkhoy-Qaisar Road Project,
Contract Package 1)

Technical Audit Final Report

Contract Number S19303

Andkhoy-Qaisar Road Project, Contract 1

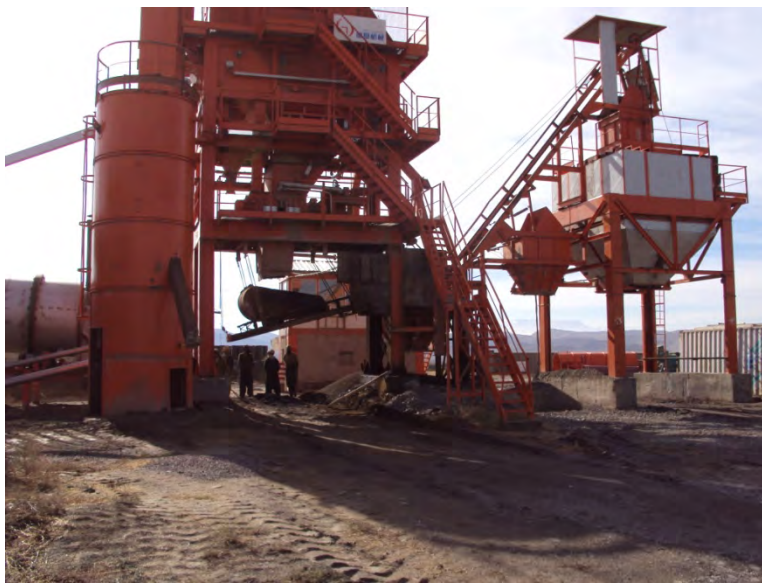
Figure 2 – Asphalt batch plant is idle

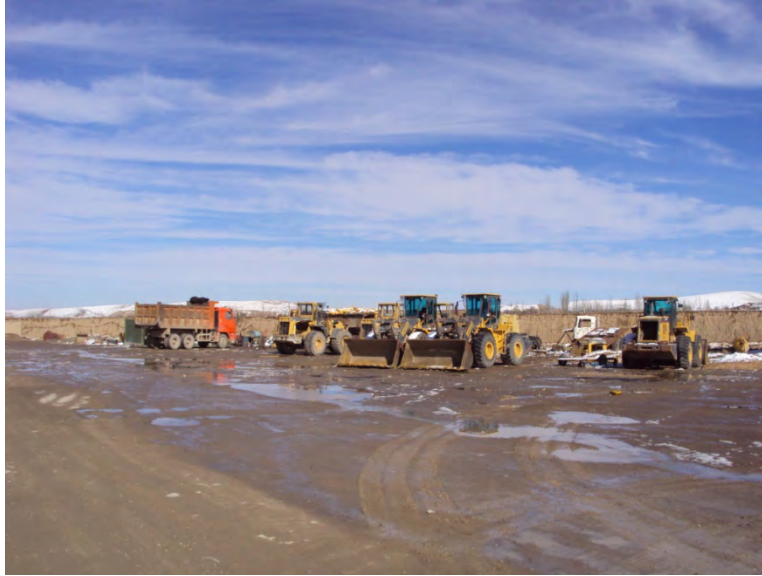
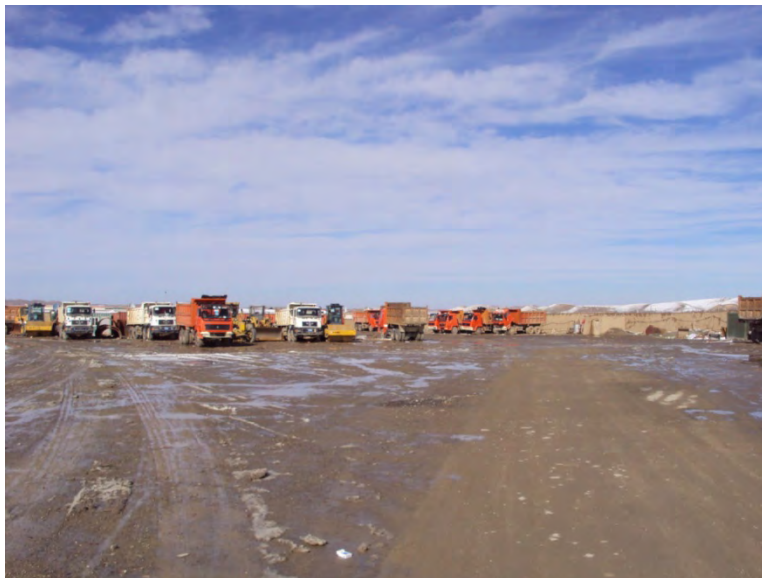
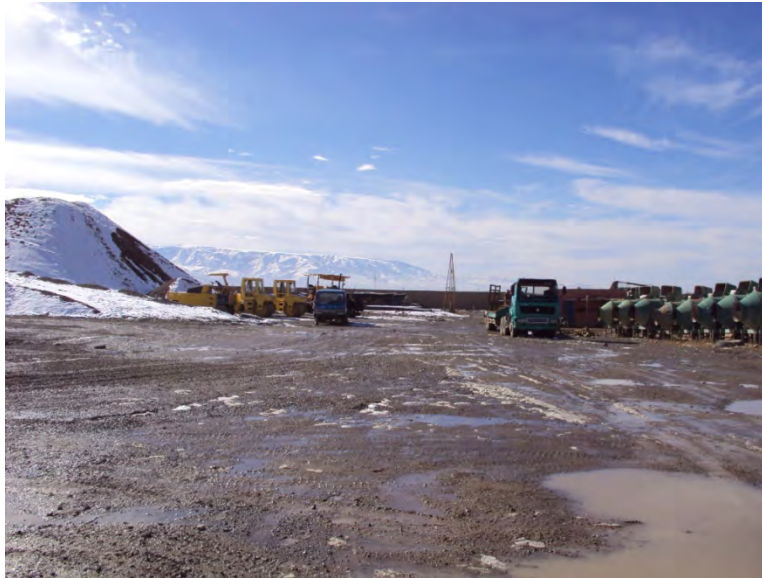
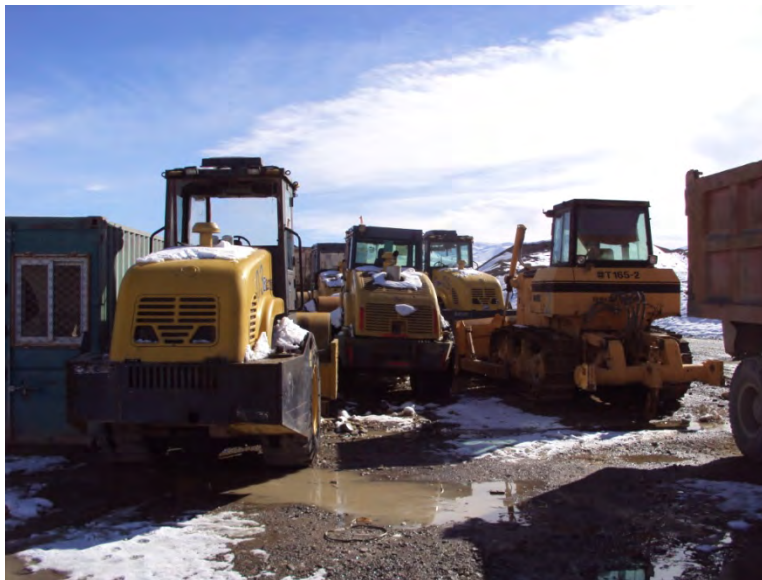
An informal count of the equipment engaged and an assessment of the construction progress on the project indicate that the Contractor and Engineer may be overreporting the amount of plant and construction equipment actually engaged on the project. Onsite observations contradict the Engineer's statements in progress reports that the Contractor is increasing resources and productivity to achieve the project schedule. The following series of photos shows that virtually all of the plant and construction equipment at the project site was idle on Thursday, November 26. This should have been a busy workday for a Contractor whose project is behind schedule.

Figure 3 - Idle equipment at the Qasir equipment yard on Thursday, November 26.

Figure 4 - Idle equipment at the Qasir equipment yard on Thursday, November 26.

Figure 5 - Idle equipment at the Qasir equipment yard on Thursday, November 26.

Figure 6 - Idle equipment at the Qasir equipment yard on Thursday, November 26.

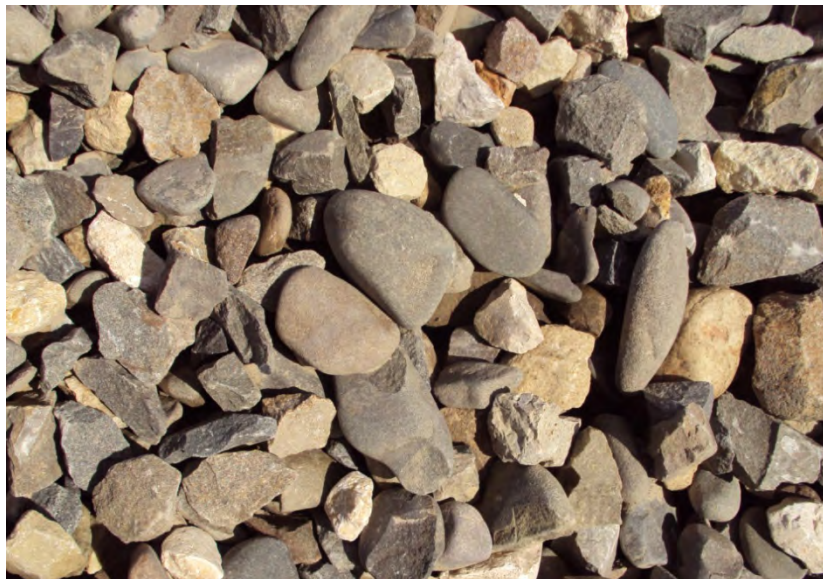
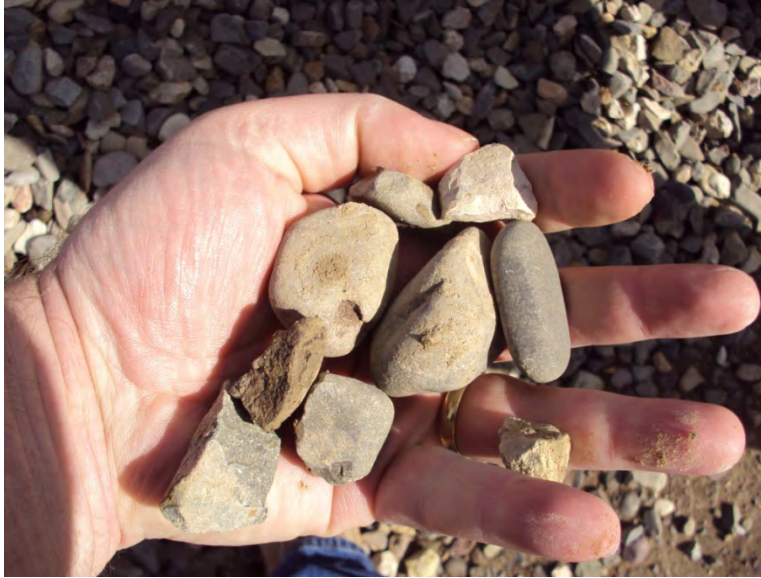
Figure 7 - Aggregates for the asphalt mix with low crushed face content-ICB1

Figure 8 - Aggregates for the asphalt mix with low crushed face content-ICB1

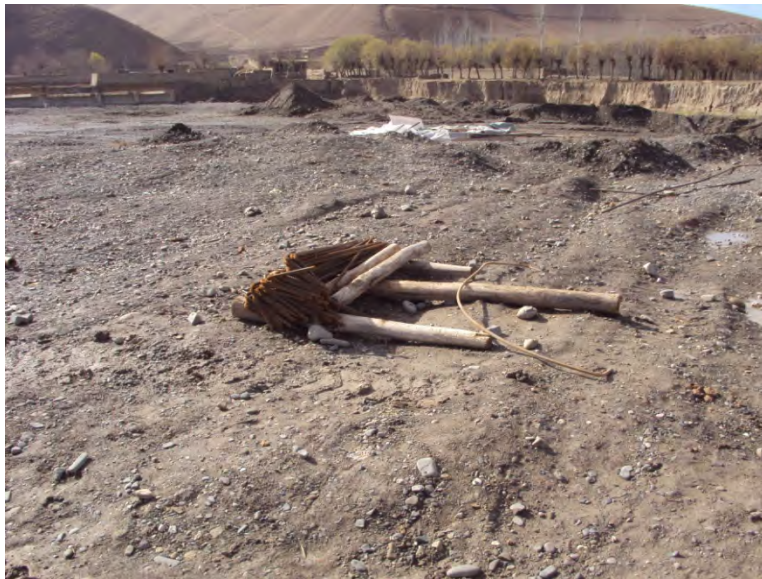
Reinforcing steel is stored outside on the ground in unacceptable weather conditions. The Engineer's plan to require inspection and cleaning of reinforcing steel before installation is an unacceptable substitute for proper storage as required by the specifications. The Engineer appears to be complicit in this and most other site issues of concern, offering excuses for noncompliant work rather than noting and responding to the issues found by the Auditor during the site visit. There are costs associated with specifications compliance and the Contractor is very unlikely to comply with quality requirements without the Engineer's diligence.

Figure 10 - Reinforcing steel is not stored as required by the specifications.

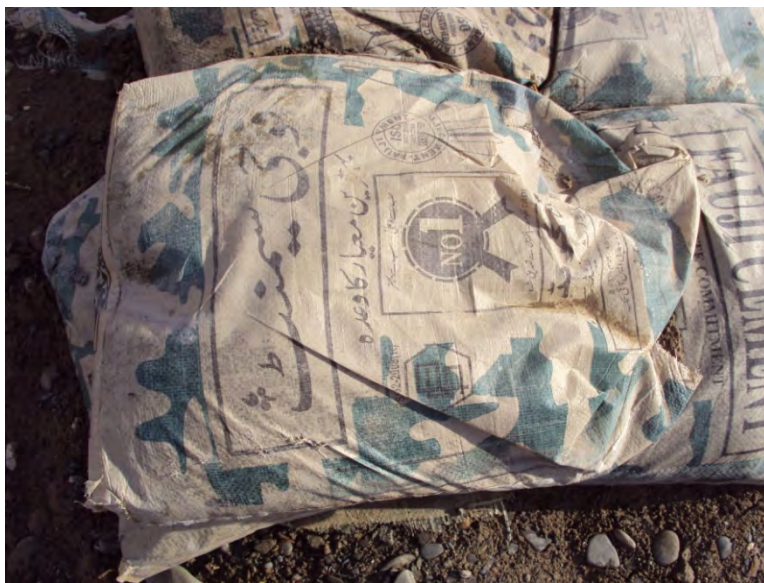
Figure 11 - Cement Bag-Front

The specifications, C900 Part A state AASHTO M85 as the required compliance standard for Portland cement for Contract 2. There are eight categories of portland cement available to designers in AASHTO M85. Sulphate Resistant Cement (Type II or SRC) is strongly recommended for bridge construction, particularly for subgrade and at-grade elements such as approach slabs, abutments, pier foundations, etc. Similarly Type II cement is recommended for concrete culverts. Depending on the sulfate content of soils or if the soils sulfate content is unknown, Type V cement with high sulfate resistance is recommended. A thorough Engineer's analysis of this material is recommended, including a soils assessment for sulfate content and a chemical analysis that indicates the sulfate resistance characteristics of the concrete in place and its predicted impact on design life. The following photos show that Ordinary Portland Cement is being used for bridge construction.

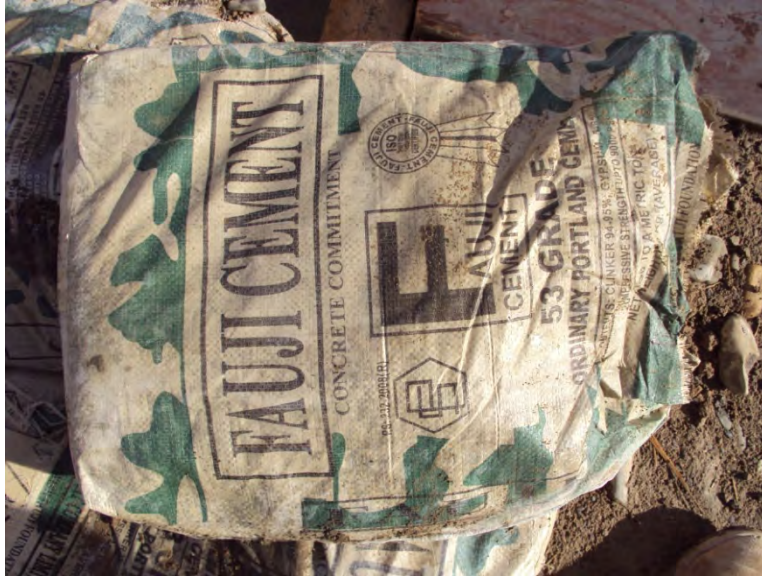
Figure 120 - Cement Bag-Back. Bags do not include the Type I/Type II designation as required by the Engineer.

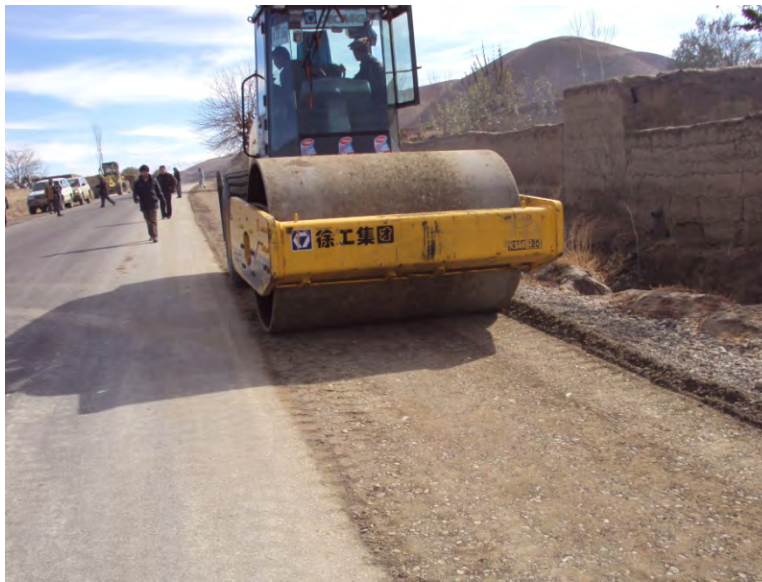
The procedures, personnel, and equipment observed during the placement of the hard shoulder were found to be acceptable. Photos of the observed operation are shown below. In general the surface quality of the finished roadway was found to be acceptable.

Figure 13 – Hard shoulder compaction

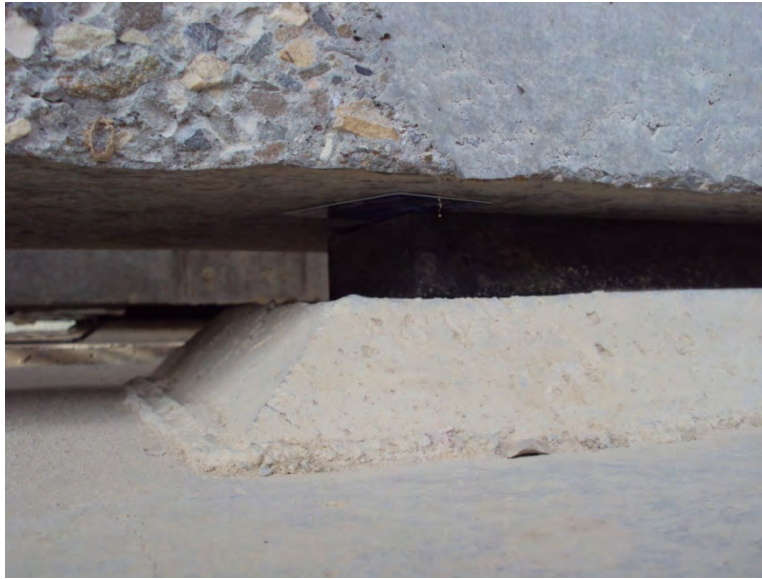
Observed bridge bearings were found to be installed on uneven pedestals. Significant visible gaps were observed between the elastomeric bearings and the girder soffit. It is unlikely that the bearing manufacturer will honor any warranty claims related to the bearings in the future given the installed bearing conditions.

Figure 14 - Uneven bearing at Bridge 3

2. Extension of Time requests beyond those already awarded and associated escalation are not justified.
3. Installed roadway materials and workmanship were found to be acceptable. Installed bridge workmanship and materials were found to be inadequate in some cases. Bridge bearings should be checked for all load conditions.

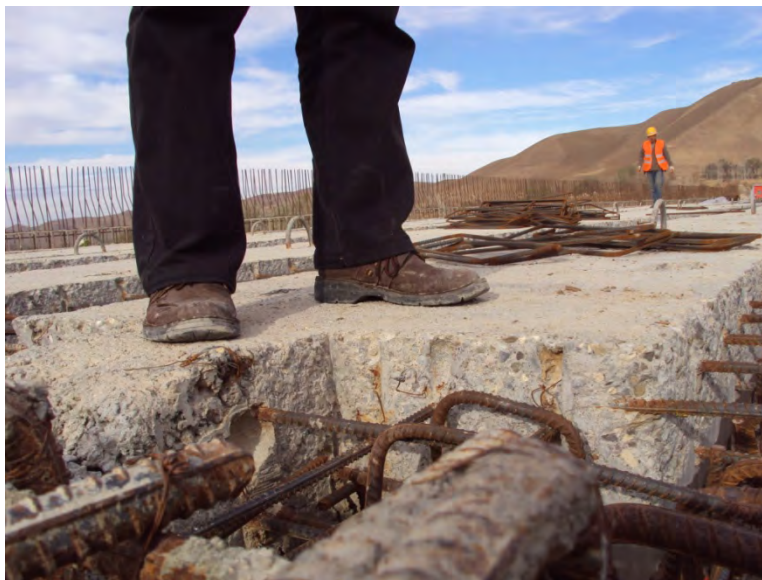
Figure 15 - Girder Positions at Bridge 3

The elevations of the top surfaces of installed precast girders appear to exceed the 5mm tolerance allowed by C300, Part 2, Table 3-3 of the specifications.

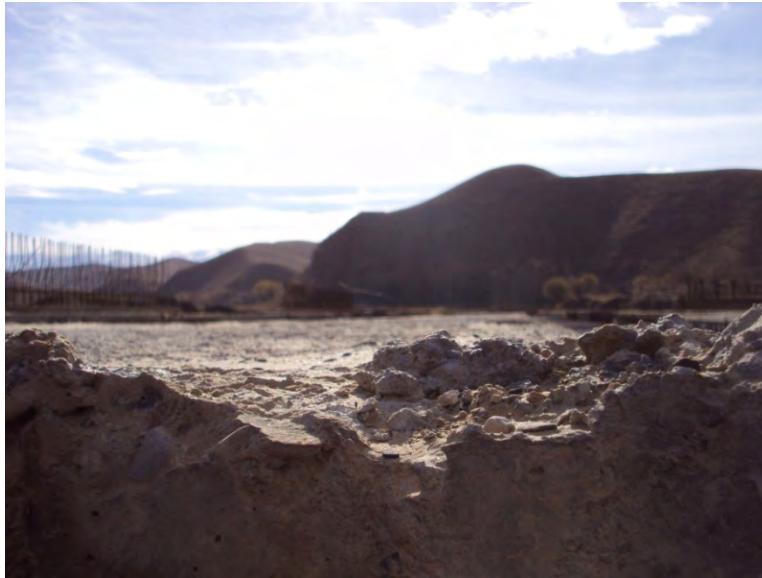
Figure 16 - Top surface of precast bridge girders do not appear to meet specified tolerances.

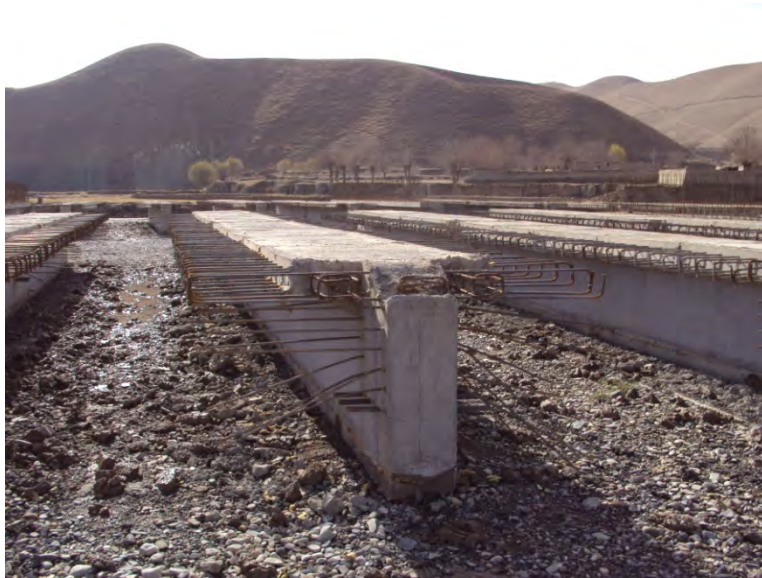
Figure 17 face of precast bridge girders do not appear to meet specified tolerances.

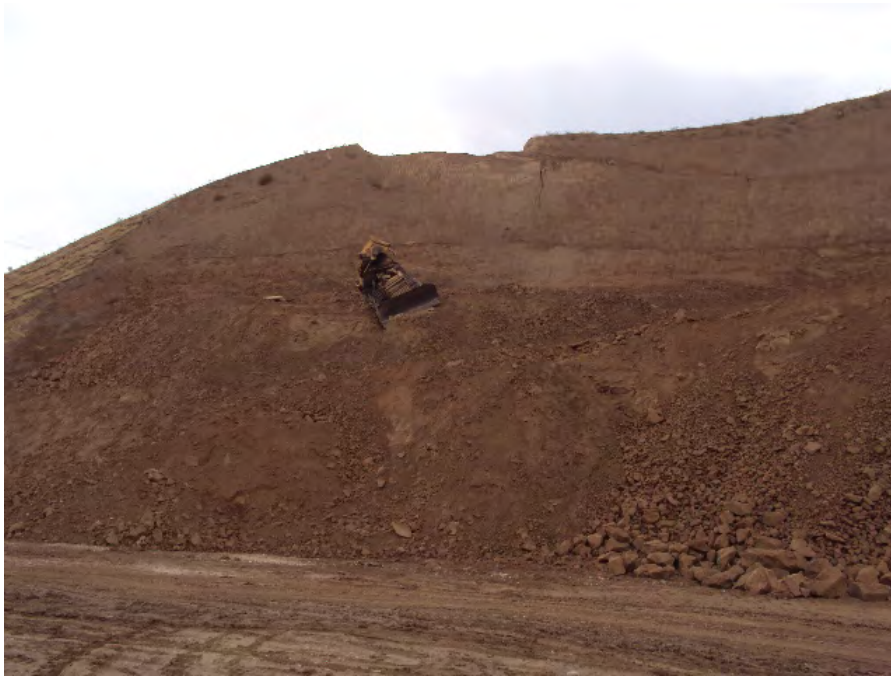
The scene of a fatal accident involving an equipment operator was observed on November 26. According to statements from witnesses to the accident, the operator was cutting earth with a bulldozer on an unstable slope and the bulldozer rolled down the hillside, catching fire. The operator died from burns and injuries either on the way to the hospital or at the hospital.

The performance of the Contractor's and Engineer's teams in response to the accident can only be rated as grossly negligent. Onsite interviews with the Contractor's Project Manager and the Engineer's Resident Engineer indicated that their responsibility with respect to the fatality ends with the issuance of a memo. Since the equipment was subcontracted and the worker was a subcontractor's employee, both the Contractor and the Engineer stated that the worker is responsible for personal safety, working conditions safety, and insurance. Onsite the Auditor strongly urged the following actions as a result of the accident, and urges the readers of this Report to follow up on the suggestions below with sanctions for noncompliance:

Figure 18 - Scene of fatal equipment operator accident

- 1. Thorough and competent investigation into the accident's cause. Adjust safety procedures and personnel in response to the results of the investigation.**
- 2. Recognition of a failure in safety procedures that led to a fatality.**
- 3. Add staff to include safety officers for the worksite. Designate a Safety Manager with responsibility for worker's safety.**
- 4. Adjust safety procedures to include daily inspections with written documentation, emergency transportation, and personnel with basic first aid training.**
- 5. Compensation for the accident victim's family.**
- 6. Verification of adequate and current insurance coverage for all subcontractors, for equipment and personnel.**
- 7. Submit written documentation of actions 1 through 6 above to the Engineer, Employer, and Donor as soon as possible.**

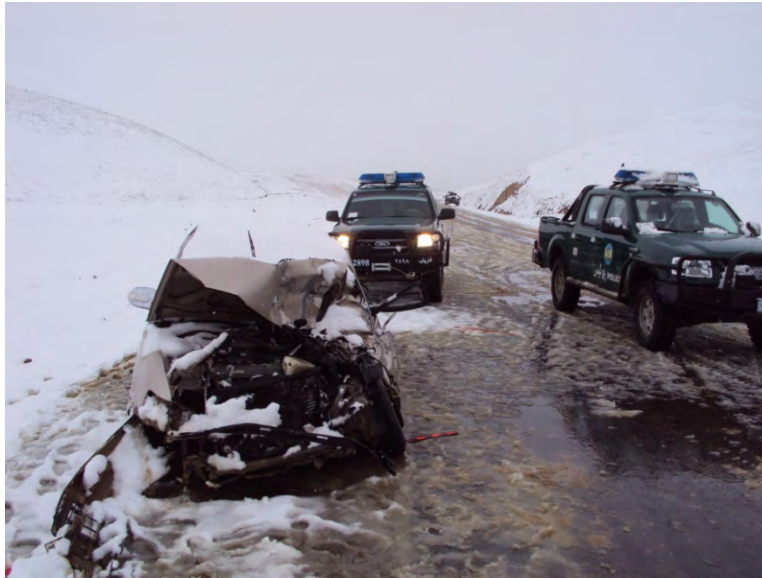
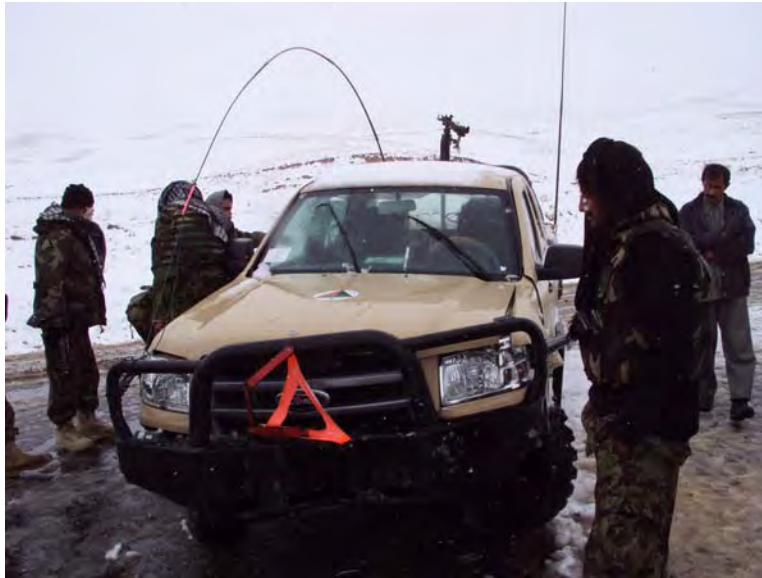
This road construction project can only be rated as poor with respect to the safety and comfort of the users of the road. No road furniture, signage, or striping has been installed to improve the road's safety for the winter months. Though it was snowing during part of the site visit, no snow removal or ice mitigation equipment was observed to be in operation on the road. The scene of an accident with serious injuries was observed on November 26. Witnesses reported that vehicle speed was a major factor in the accident's cause. If speed limits were posted or the road had been salted/sanded the accident may have been prevented. There were multiple injuries and the most seriously injured victims had been transported to the hospital when the Auditor arrived on the scene.

Figure 19 - Damaged vehicle in November 25 accident.

Figure 21 - Damaged vehicle

The creation of a road hazards mitigation plan by the Contractor in close cooperation with the Engineer is recommended.

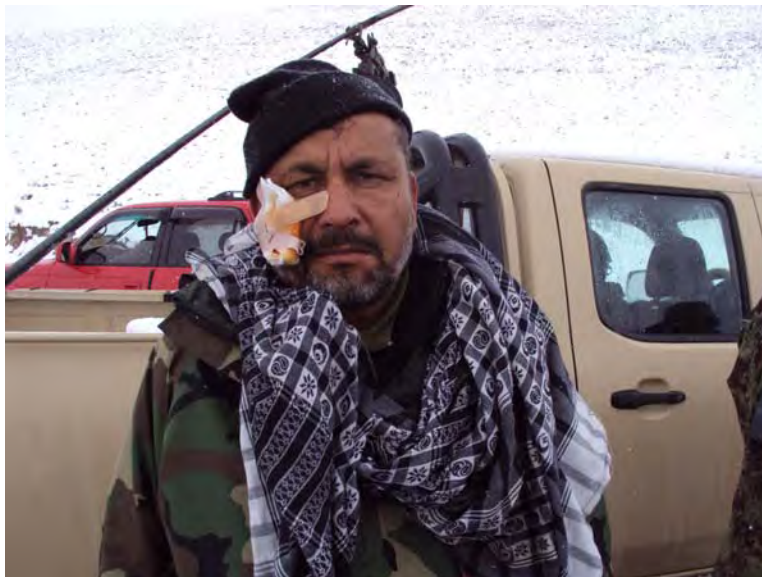
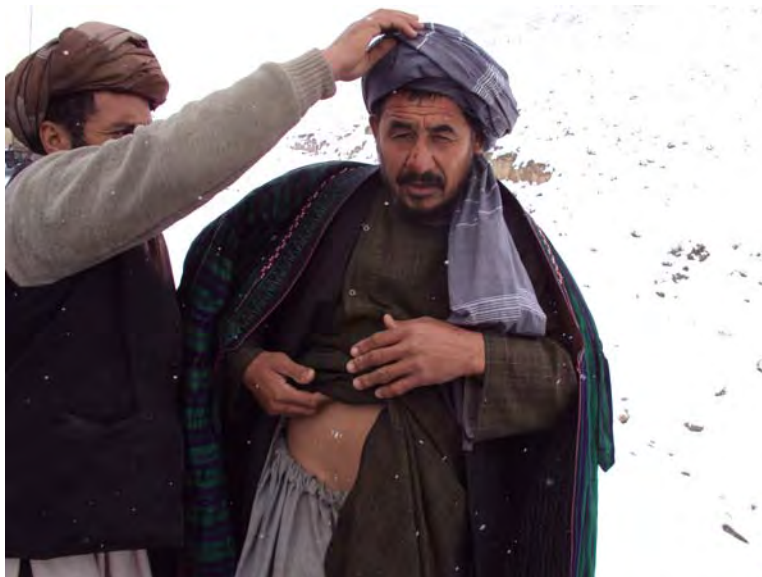
Figure 20 - Accident victim

Figure 22 - Accident victim
