## Sri Lanka: Southern Transport Development Project JICA Funded Section-Package 2

**SOUTHERN TRANSPORT DEVELOPMENT PROJECT  
JICA FUNDED SECTION PACKAGE -2  
(DODANGODA TO KURUNDUGAHAHETEKMA)**

**BI- ANNUAL ENVIRONMENTAL IMPACT  
MONITORING REPORT**

**JULY TO DECEMBER 2009**

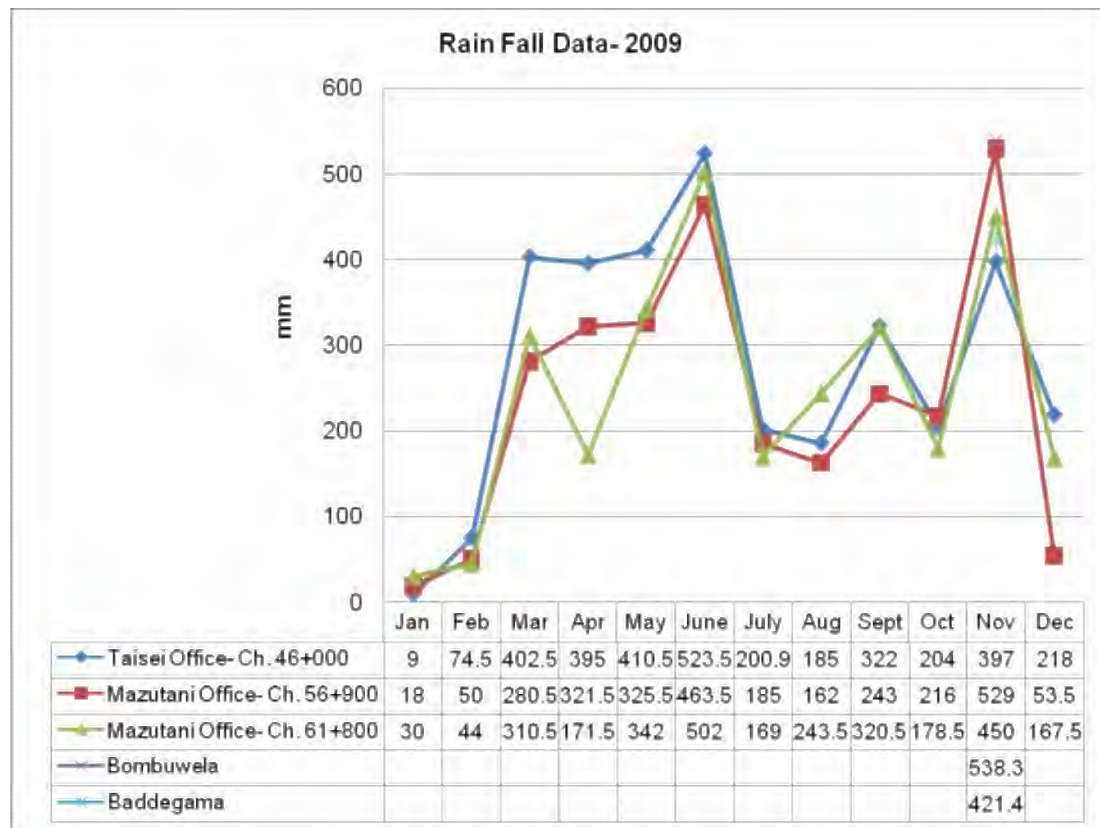
**Figure -01- Rain Fall data from July to December 2009**

The construction activity along with the rains compounded the problems of silt deposition and flooding. Therefore, rainfall data collected as a prominent indicator of environmental degradation along the trace. The rainfall data has measured continuously from July to December 2009. Rainfall data measurement was carried out at five locations in Taisei Office (Ch.46+000), Mazutani Office (Ch.56+900), Mazutani Office (Ch. 61+800), Bombuwela and Baddegama. The high rainfall was experience during November in the 2<sup>nd</sup> half of the year 2009 at the STDP JICA - Package 2 section (Figure 01).

The construction activity during the rainy season aggravates the problem of the silt deposition due to soil erosion at open areas. Most of the culverts were blocked due to siltation during the rainy season and the culvert-clearing programme was launched during the period. In addition, construction firm provides sedimentation trap and basin, temporary beams/bunds, temporary slope drains, temporary diversion boulder packing to prevent the siltation in the downstream.

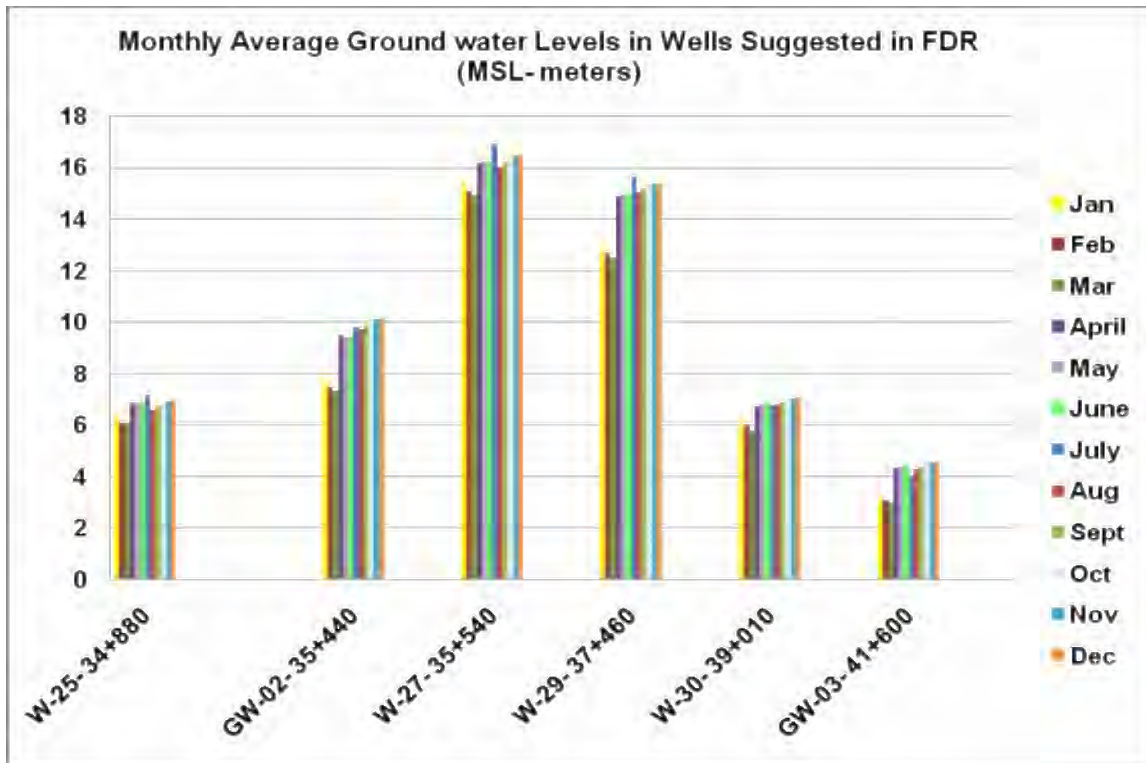
**Figure 02- Monthly Average Ground water Levels in Wells Suggested in the FDR- 2009**

The above results reveal that no significant drop of the ground water levels at locations suggested in the FDR and approximately the CVC areas during the reporting period. However, variation in the monthly average groundwater levels both at the locations suggested in the FDR and approximately CVC areas can be observed; may be corresponded with the monthly average rainfall.

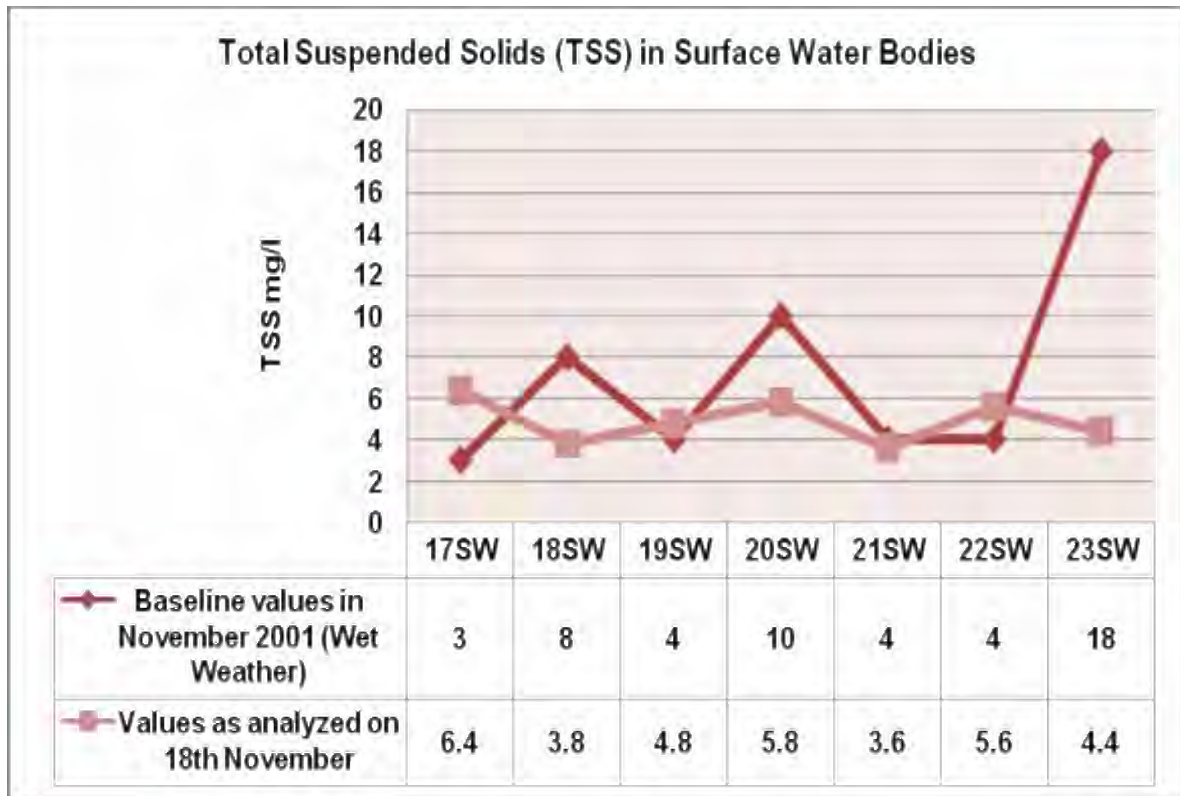
**Figure 04- Total Suspended Solids (TSS) in Surface Water Bodies**

The above figures show no remarkable change in the pH values and an increase of TSS in surface water bodies due to construction of expressway.

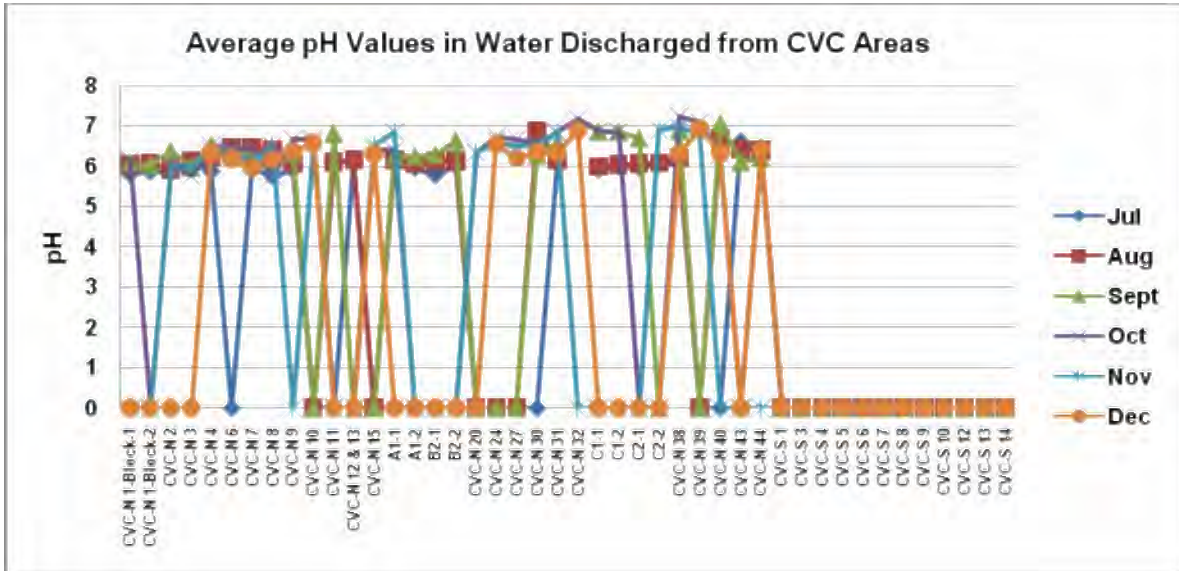
**Figure 6- Average pH Values in Water Discharged from CVC Areas**

The above pH monitoring results reveal that pH in water discharged from CVC areas during the reporting period is complying with the General Standards for Discharge of Effluent into Inland Surface Waters, stipulated by the CEA, except at a few location.

The said exceptional cases may be natural by referring to the pH in the wells adjacent to CVC areas (Please see Table 20) and the report of the water quality of the surface water bodies as given in the FDR (Please refer the table 6.6 at page 142 of the FDR ), which also shows low pH values in ambient waters. So that pH in water discharged from the CVC areas may not adversely affect to the environment. However regular monitoring of pH in water discharges from the CVC areas and in ambient waters, both surface and ground is recommended and if such regular pH monitoring reveals any kind of adverse effect to environment, Contractor should take immediate actions to adjust pH in CVC waters to permissible levels prior to discharge to environment.

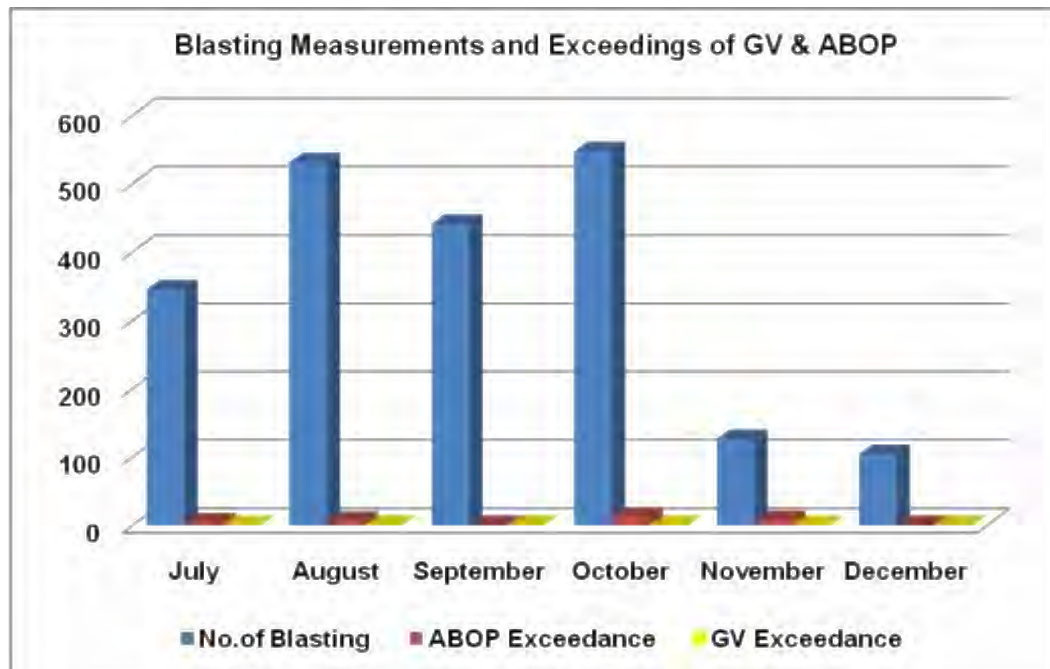
**Figure 7- Number of Blasting Measurements and Exceeding of GV & ABOP**

Air blast over pressure and ground vibration was measured at the complaints houses during the blasting take place. Figure-6 shows the number of measurements carried out during the months July to December 2009 and the number of exceeding of ABOP and Ground vibration.

During the reporting period, 2094 numbers of blasting were monitored by GSMB. 28 Numbers of exceeding of Air blast over pressure measurements were reported during this period. Moreover, ground vibrations exceeding were not recorded during this period. Test blast is carried out at every location prior to production blasts to obtain GSMB mining license and Environmental recommendation from CEA.

The impacts to the public owing to rock blasting were minimized by evacuating on long term and short-term basis according to the conditions in the Mining Licenses with paying an evacuation fee. Fly rocks have been controlled by using an appropriate covering method (Heavy Blasting Net).

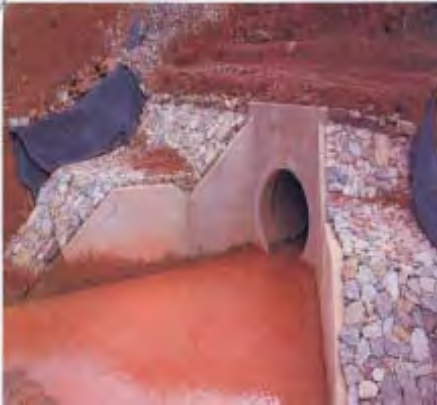
Environmental Concern	Objectives	Impact and location	Mitigation measures implemented	Comments/Status
<p><b>1. Hydrology and Drainage</b></p>	<p>1.To ensure the proper implementation of activities mentioned in CEA conditional approval letter and</p> <p>2.To avoid deterioration of water quality, sedimentation, temporary flooding, creation of stagnant water bodies and effects on ground water level and quality</p>	<p>1. Soil erosion and sedimentation experienced at locations, vulnerable to erosion (silting of culverts, sediment basins and trenches).</p>	<p>1. Erosion and sedimentation control measures such as construction of sediment basins, trenches, covering the embankments and de-silting of culverts, sediment basins and trenches have been implemented at sites vulnerable to erosion.</p>

<p>Ch.36+857</p>	<p>1. However, at following locations, de-silting of culverts has still not been completed.</p> <p>Ch.60+500(LHS), Ch. 57+520(RHS), Ch. 37+000~Ch.38+000(LHS)</p>

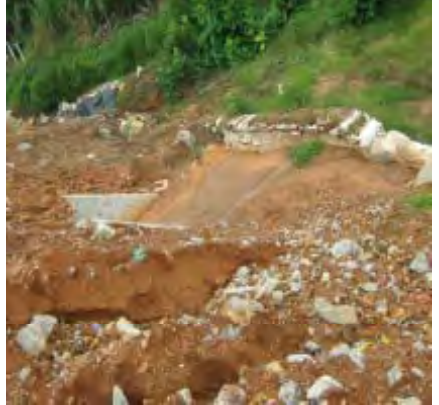
<p>Sand bags piled at the edge of the embankment were torn.</p> <p><b><i>(Instructions have been given)</i></b></p>

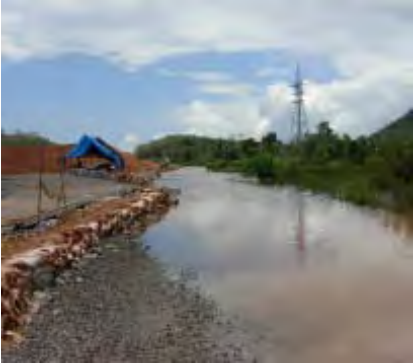
<p><b>1. Hydrology and Drainage</b></p>		<p>2. Lack of lead away to cater the storm water and inundation of pilot road.(some places along the pilot road) Ch. 46+420 (LHS)</p>

<p>3. As in the permanent road, design has been kept due to difficult to provide such openings since construction activities are still underway.</p> <p>4. Contractor has taken necessary steps to attend/ resolve these complaints. Systematically collected and analyzed the complaints on drainage issues.</p>	<p>2. Successful, However, regular maintenance required. However, the Contractor should take precautionary actions to prevent pilot road flooding.</p> <p>3. Flood release openings should be provided Till permanent structures are completed contractor should take measures to facilitate proper drainage at all vulnerable locations for flood and at areas where difficulty to take such action Contractor should be vigilant on any damage to outsiders due to flood aggravated with necessary action to implement the contingency plan.</p> <p>4. Out of 90 complaints related to flood issues, 89 complaints have been attended/ resolved. (See, Table 26 at Chapter 6).</p>

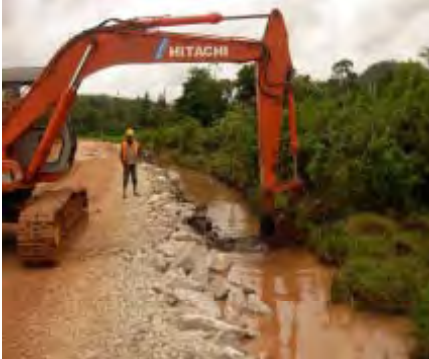
<p>3 No required flood release openings in areas such as Ch. 45+300-Ch. 46+620 (Welipenna Flood Plane) and Ch. 47+500-Ch. 48+100 (Miriswatte Flood Plane)</p> <p>4. Public complaints regarding flood issues</p>	<p>2. Improvement of toe drains to facilitate drainage.</p>

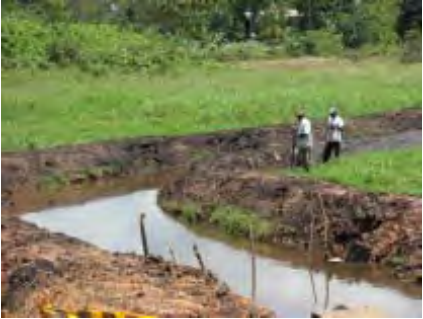
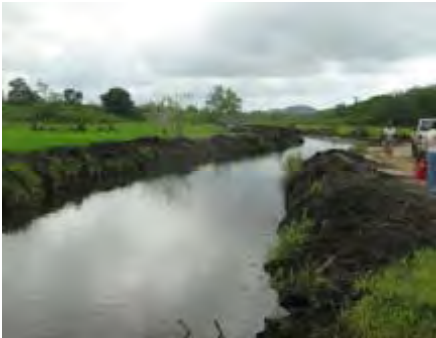
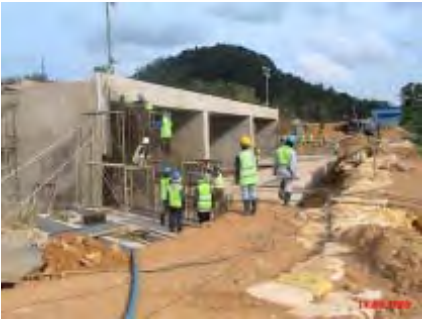
<p><b>1. Hydrology and Drainage</b></p>		<p>5. Lack of lead away to cater the storm water, and, Inadequacy of capacity of lead away beyond ROW. (Lead away drainage issue is one of the leading issues of the project) E.g. Ch 54+ area</p> <p>6. Expected flood issues due to inadequacy of capacity of Irrigation channels. E.g. Lewwanduwa Ela, Paraigama Ela and Parallel channel along the Ela, Duwa Ela, Lanthiri Ela, Welipenna flood prone area</p>	<p>5. After improvement</p>

<p>5. Frequently cleaning is required (Remaining).</p> <p>6. Improvement activities are Successful. However, regular cleaning and maintenance is required. (← Improvement of Irrigation channels and construction of drainage structure at Ch. 46+ 480 - Welipenna flood prone area)</p>
---	--	--	---	--

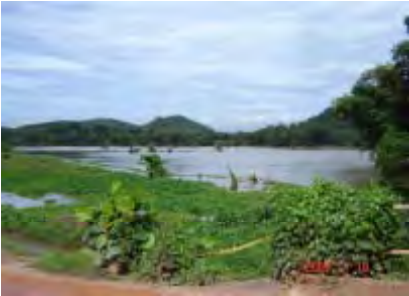
<p><b>2. Surface and Ground Water Quality</b></p>	<p>1.To ensure the proper implementation of activities mentioned in CEA conditional approval letter and</p> <p>2.To avoid deterioration of water quality and prevent adverse water quality impacts due to negligence</p>	<p>7. Flood situation recorded due to heavy rains. E.g. Up stream flood at Ch. 45+300 (LHS)</p>

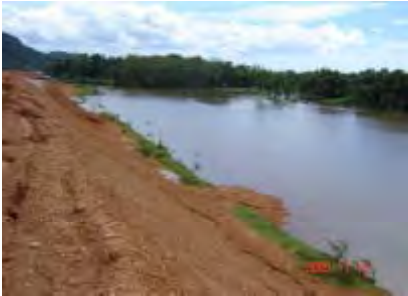
<p>8. Expected drop in the water levels and deterioration of water quality in the water levels at locations suggested in FDR at CVC areas.</p>	<p>7. Any adverse impact to upstream was not recorded. E.g. Down stream flood at Ch. 45+300 (RHS)</p>

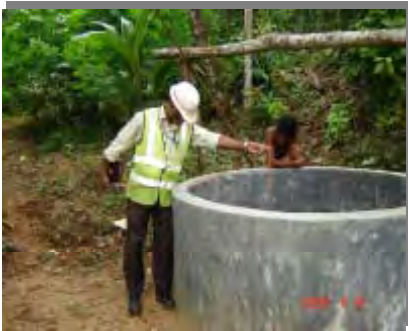
<p>Public complaint on contamination of well with silt has been attended and cleaned by dewatering. Ch. 50+500 (RHS)</p>	<p>7. No any adverse flood situation recorded.</p> <p>8. Results reveal that no significant drop in the water levels and salinity and pH in water discharged from the CVC areas may not adversely affect to the environment; therefore need for any mitigation measures did not arise. (Refer Chapter 4.2-Table 19 &amp; Figure 03, Table 20, Table 21 - Figure 05 &amp; Figure 06).</p> <p>If such regular pH monitoring reveals any kind of adverse effect to environment, Contractor should take immediate actions to adjust pH in CVC water to permissible levels prior to discharge.</p>

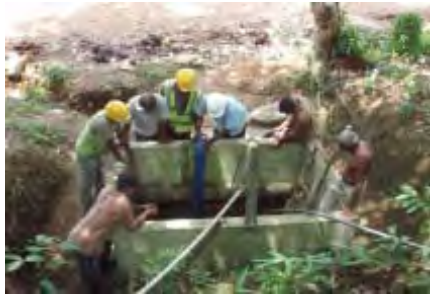
<p><b>2. Surface and Ground Water Quality</b></p>		<p>9. Oil spills from machinery, construction vehicles and equipments</p> <p>10. Discharging wastewater generated from the concrete batching plant at 59+700 in to a natural water way.</p>

<p>9. Regular and proper maintenance of machinery, construction vehicles, and equipments have been carried out to prevent oil spills.</p> <p>10. Wastewater generated from the concrete batching plants at 59+700 is being treated using sedimentation tanks prior to discharge</p>	<p>9. Contractor shall ensure that any oil contaminated water discharge to water bodies from machinery, construction vehicles, and equipments is prevented and to maintain them in proper working order.</p> <p>10. The treatment process of the wastewater in the batching plant at Ch. 49+500 is not satisfactory; Batching plant's wastewater has been sampled by the University of Moratuwa on 01<sup>st</sup> July 2009 for quality analysis as per the conditions in the EPL and the report of the same reveals that the level of pH and Total Suspended Solids has not been maintained according to the tolerance limit of the CEA.</p> <p>Contractor should take Immediate action to upgrade the sedimentation tanks and Engineer, Management Consultant and Employer to monitor through joint field inspection.</p>

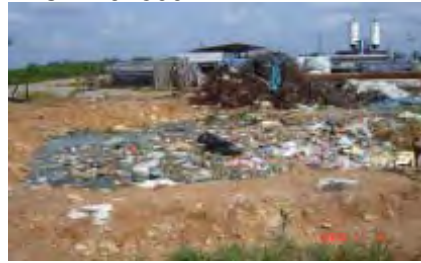
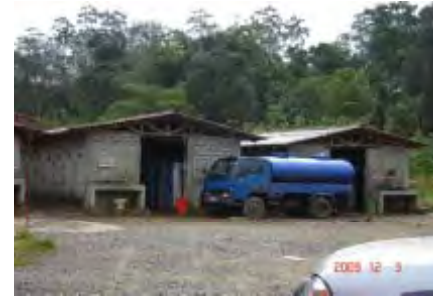
12. Open discharge of domestic wastewater and haphazard disposal of solid wastes in the Foreign Employees dormitory at Ch. 49+500.

Regular removing of sewage from Employee's Accommodation at Ch. 49+ 500 (RHS) is being practiced by the Contractor as per the conditions in the EPL.

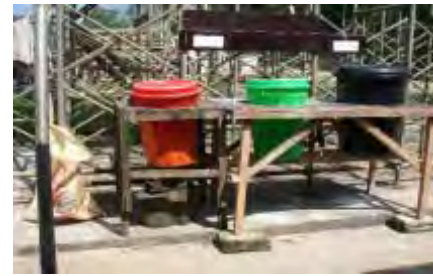
12. Contractor has attended and rectified. Introduction of a Solid Waste Management system

11. Contractor should adhere to the conditions in the Environmental Protection Licence (EPL) issued for the foreign employee's accommodations and motor pool very essentially.

12. Rectified according to the conditions in the Environmental Protection Licence (EPL)

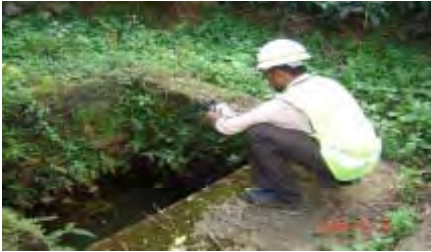
<p><b>2. Surface and Ground Water Quality</b></p>		<p>13. Water quality deterioration due to unsuitable materials disposal within ROW.</p>	<p>13. Temporally disposed unsuitable materials within ROW should be removed to approved locations. Monitoring pH in a well close proximity to disposal site at Ch. 44+180</p>

<p>13. Contractor should take action to remove temporally disposed unsuitable materials within ROW to approved locations.</p>
<p><b>3. Soil erosion / Surface runoff</b></p>	<p>1. To minimize soil erosion due to the construction activities of highway</p> <p>2. To prevent adverse water quality impacts due to negligence</p> <p>3. To ensure unavoidable impacts are managed effectively</p>	<p>14. Erosion and sedimentation due to unsuitable materials loosely disposed adjacent the ROW. E.g. Ch. 64+100 (LHS) Soil and silt washed out from the unsuitable soil disposal site are deposited onto a Cinnamon cultivated land during the rainy season.</p>

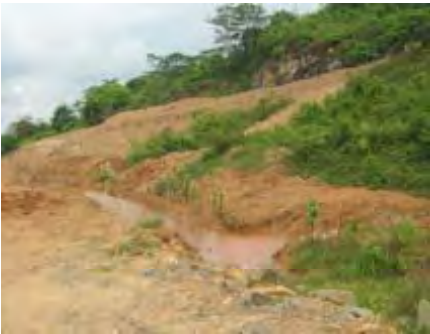
<p>14. Sufficient mitigation measures not yet taken by the Contractor. However, check dams were built across the drain.</p>	<p>14. Contractor should take action to compact loosely disposed soil and debris should be compacted. The Cinnamon cultivated land should be desilted. A drain and check dams to be constructed around the disposal sites.</p>

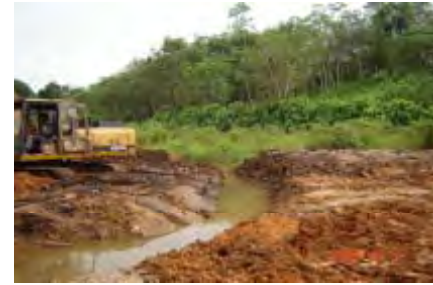
Provision of drainage at disposal site at Ch. 50+500 (RHS)

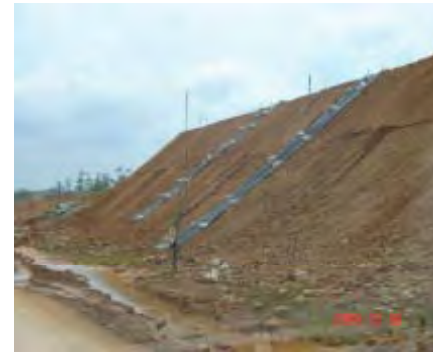
Embankment erosion control measures at Ch. 58+700

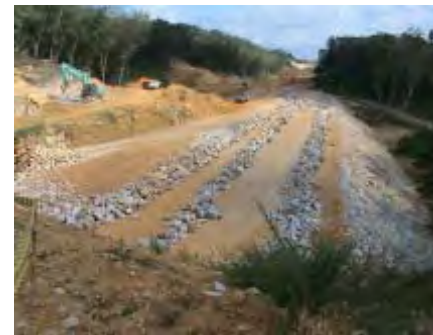
The Polythene sheets should be extended to prevent soil erosion.

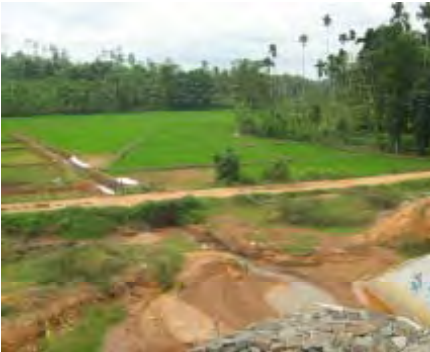
<p>Rock embankment location at Ch. 48+300 area.</p> <p>16. Mitigation measures applied to control siltation of the paddy fields by embankment erosion. E.g. Ch. 58+700 (LHS) Ch.40+061(RHS),</p>

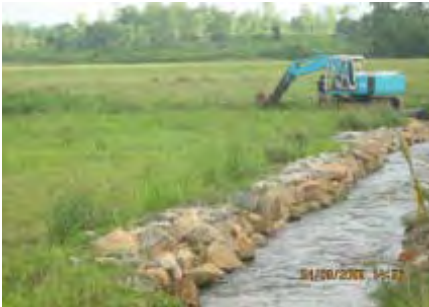
<p>Toe drain provided at Ch. 58+700 (LHS)</p>	<p>16. Paddy land siltation due to lack of mitigation measures were noticed in some area. E.g. Ch.62+900(RHS), Ch. 37+950 (LHS)</p>
--	--	--	--	---

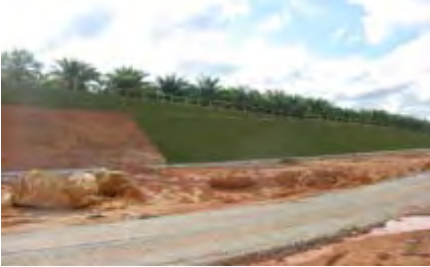
<p><b>3. Soil erosion / Surface run-off</b></p>		<p>7. Soil erosion and sedimentation from the, Cut areas.</p>

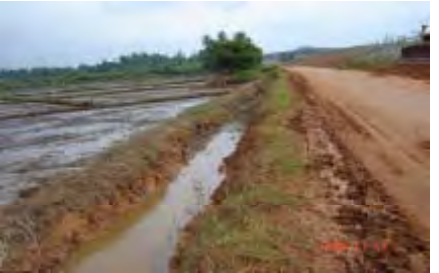
<p>18. Accidental siltation issues</p>

<p>18. Accidental siltation issues were solved by compensating. Evaluating the damages to paddy fields and crop lands due to siltation by Taisei Environment Officers joint hand with the farmers</p>

<p>Regular maintenance required.</p> <p>17. Cut slopes turfing activities have been started and continuing.</p> <p>18. Contractor should take firm actions to mitigate such accidental siltation.</p>
---	--	---	---	---

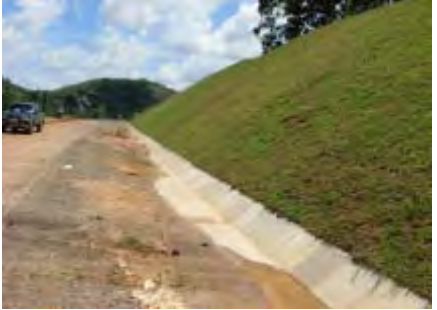
<p>17. cut slopes turfing</p>

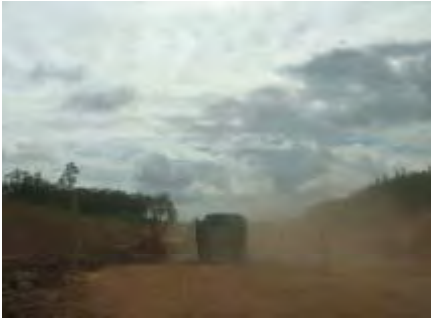
<p><b>4.Air Quality</b></p>	<p>1.To ensure the proper implementation of activities mentioned in CEA conditional approval letter and</p> <p>2.To avoid deterioration of air quality and prevent adverse impacts due to construction activities</p>	<p>19. Smoke emissions from heavy vehicles and machinery, dust emanation owing to operation of vehicles on the pilot road and dust emission from track drill machines</p>

<p>19. All heavy equipment and machinery have been regularly maintained to avoid smoke emissions.</p> <p>Speed limits have been rigorously enforced within ROW (30Km/hr).</p> <p>Dust emanation owing to operation of vehicles on the pilot road has been controlled by frequent watering.</p>

<p>19. The vehicle speed limit appears to have not been adhered to by the Contractor's vehicles.</p> <p>Pilot road should be wetted adequately and the frequency of watering should be increased in the dry period. E.g. Ch. 36 ~ 37 and Ch. 41 area</p> <p>20. Completed. Regular maintenance required</p>

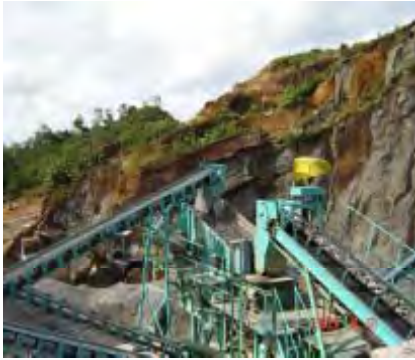
<p>20. Dust emanation owing to operation of the Stone Crushing Plant.</p>

<p>20. Dust screen has been erected to control dust emission and water sprinklers have been operated.</p>

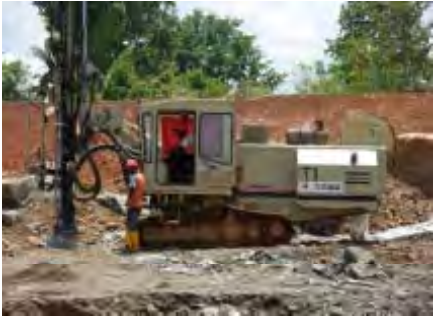
<p><b>4. Air Quality</b></p>		<p>21. Uncontrolled dust emission from track drill machines were observed during this period also due to failures in dust absorption systems.</p>	<p>21. Heavy equipment operations have been restricted to daylight hours in sensitive locations.</p> <p>Vibration and air blast over pressure have been minimized by controlled rock blasting activities and with implementing proper evacuation procedure.</p> <p>The ground vibration and air blast over pressure levels generated owing to rock blasting is complied with the maximum permissible levels as specified in interim standards except an increase of air blast over pressure in twenty eight instances out of 2094 No's of blasting.</p>	<p>21. However Contractor has taken action to install dust collectors.</p> <p>Contractor shall ensure that track drill machines are in well fitted condition to operate at the site.</p>

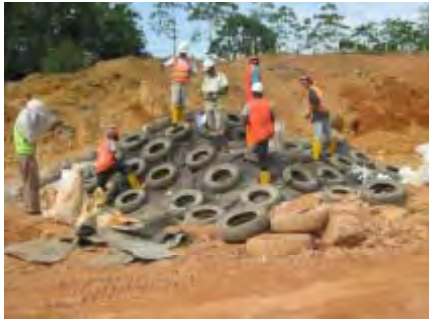
<p><b>5. Noise/ Ground vibration</b></p>	<p>1. To minimize excessive Noise and Ground vibration due to the construction activities of highway</p>	<p>22. Noise and Ground vibration due to heavy equipment operations, rock blasting activities and noise generated from CVC generators and pumps.</p>

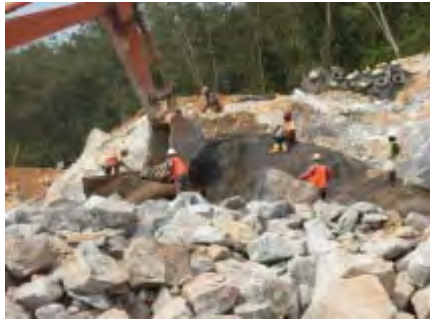
<p>22. Fly rocks have been controlled by an appropriate covering method approved by the GSMB and Engineer.</p>

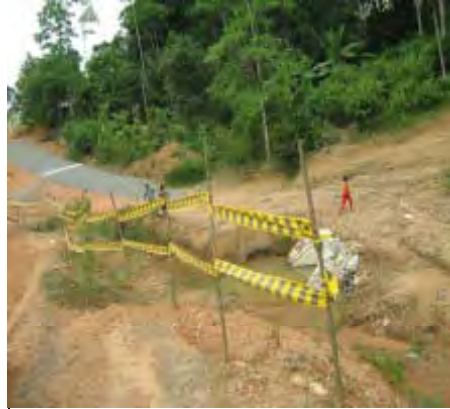
Although safety barricade tapes have been fixed on the road trace, no barricades installed at the village side.

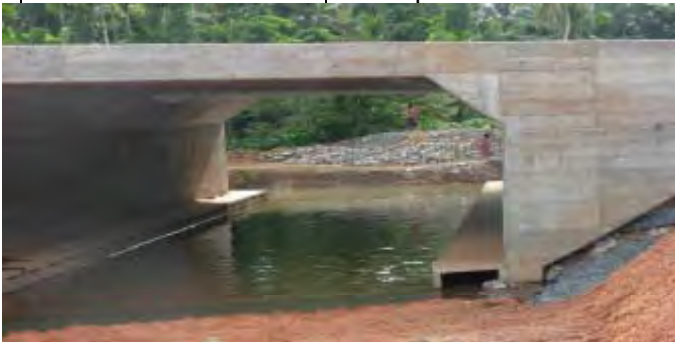
27. Water ponding area under the bridge has not barricaded. Little children were playing close to the water pond. Ch. 44+800

27. Inform the CSC to instruct the Contractor to  
- dewater the water pond  
- barricade the area  
- exhibit warning signs and banners as to see the people not to give opportunity to the children to enter this unsafe area.
