Technical Audit Final Report
(Loan 2140-AFG: Andkhoy-Qaisar Road Project,
Contract Package 1)

Technical Audit Final Report

Contract Number S19303

Andkhoy-Qaisar Road Project, Contract 1

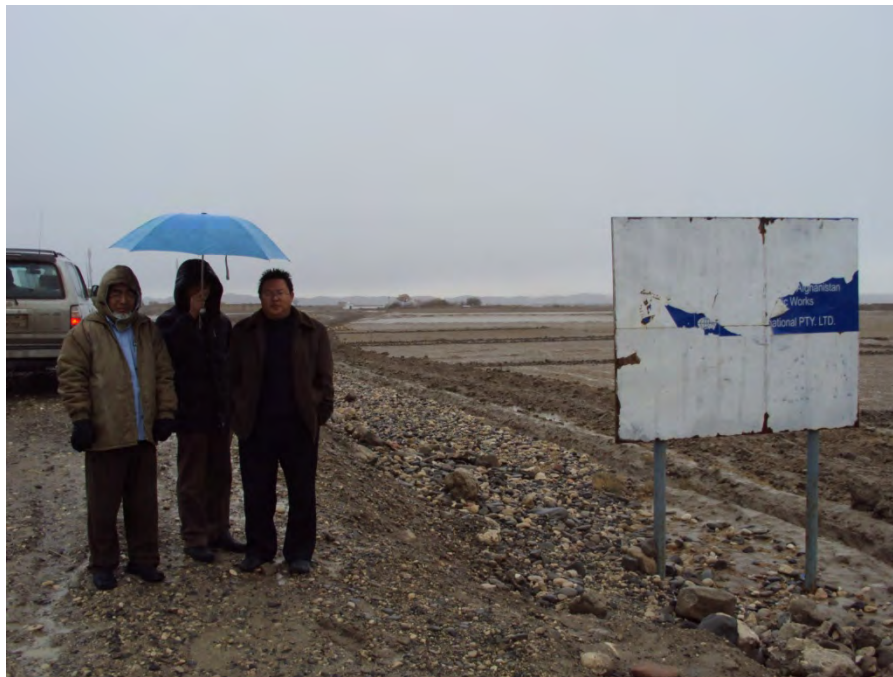
Figure 1 - ICB1 Engineer and Contractor management team. ADB project sign is to the right.

The staffing levels of both the Engineer and the Contractor were evaluated and found to be insufficient to properly monitor and document the project. The Engineer's administrator was not found to be competent to manage engineering and construction documentation. The Engineer's Team Leader was not found to be objective with respect to review of the Contractor's outputs, offering little in the way of meaningful, actionable analysis. The Engineer's Team Leader was not found to be efficient in project communications and did not offer useful clarifications while under the Auditor's observation.

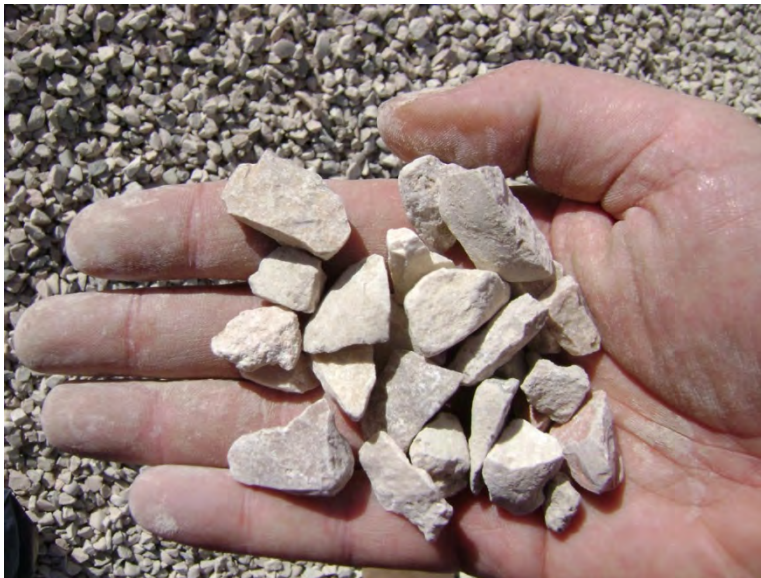
Figure 9 - Random Sample of Coarse Aggregate at Mainema-ICB2 (shown for comparison)
