PRC: Taiyuan-Zhongwei Railway Project Environmental Monitoring Report – 2009 Annual Report

Prepared by: Beijing OASIS Environment Protection Technology Co., Ltd.
People's Republic of China

Environment Monitoring Report

(2009 Annual Report)

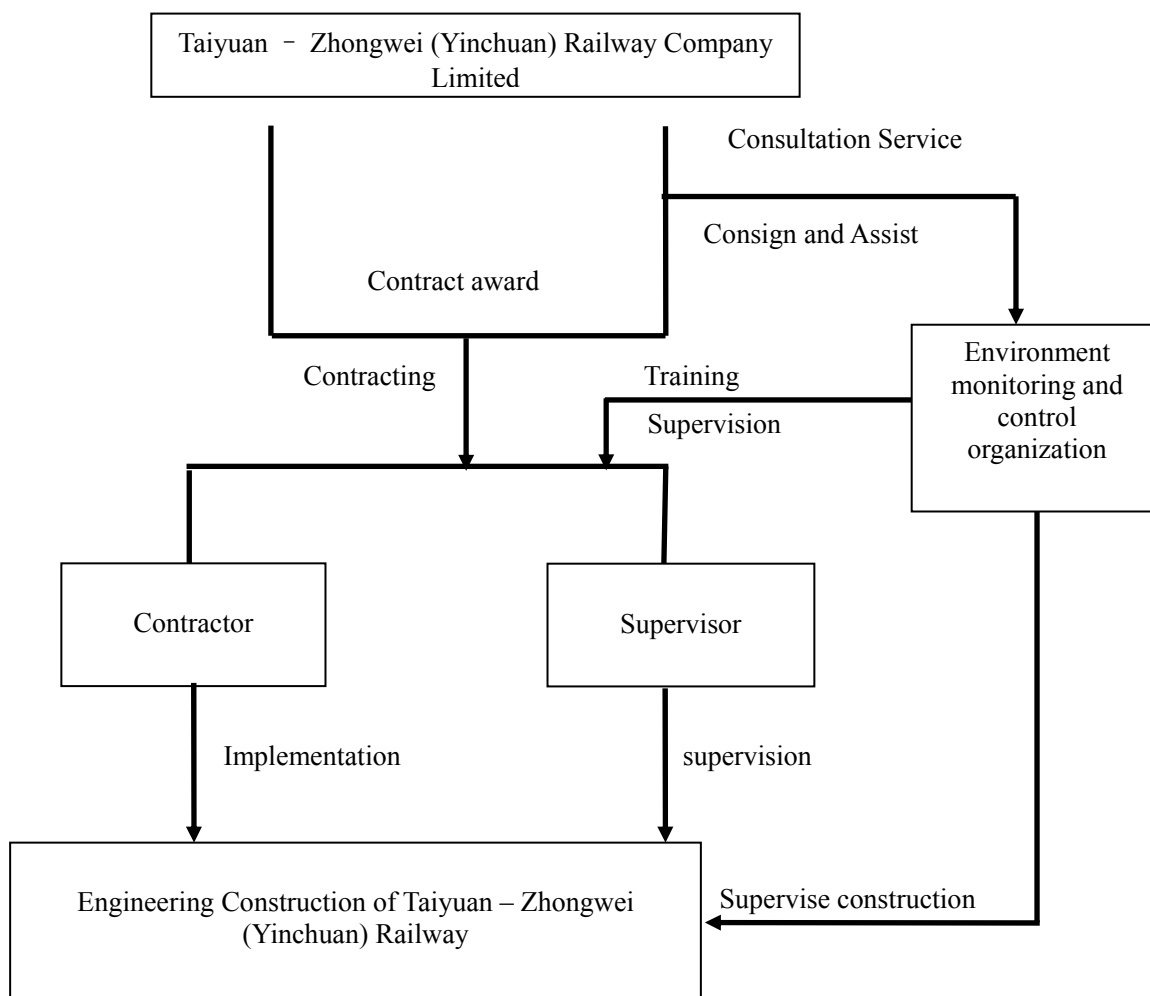
Figure 3-1: Block Diagram of Environment Monitoring System

collect various monitoring data and AOSIS Company is responsible to prepare the monitoring report and submit it to the Ministry of Railways and Asian Development Bank. The monitoring organization worked out the block diagram on environment monitoring program of Taiyuan – Zhongwei (Yinchuan) Railway (Figure 3-1) as required in the monitoring contract.
