Environmental Monitoring Report

INDONESIA: Tangguh Liquefied Natural Gas Project

**Operator's Environmental, Health and Safety Report
Tangguh LNG Project**

October 2006-April 2007

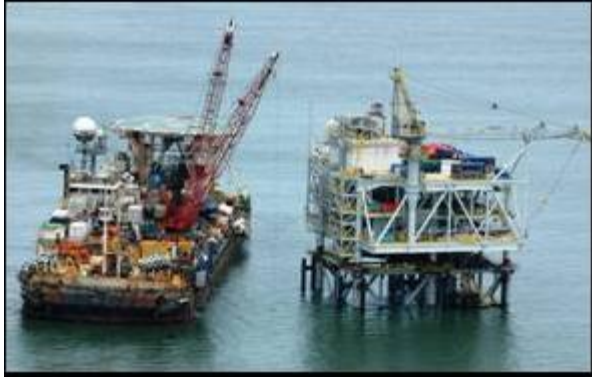
VR-A Platform

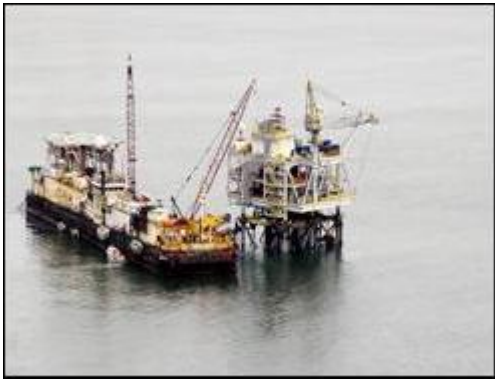
VR B Hook up & Spool Tie in

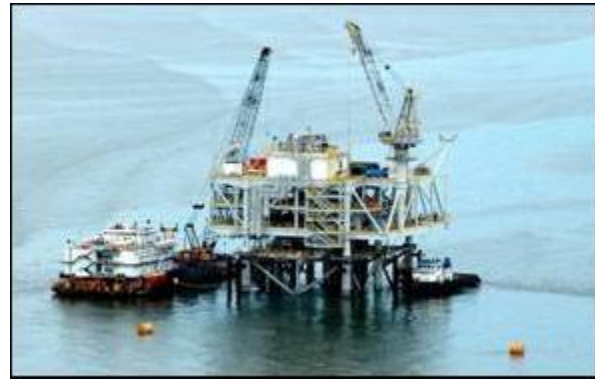
VR-B Platform Hook Up

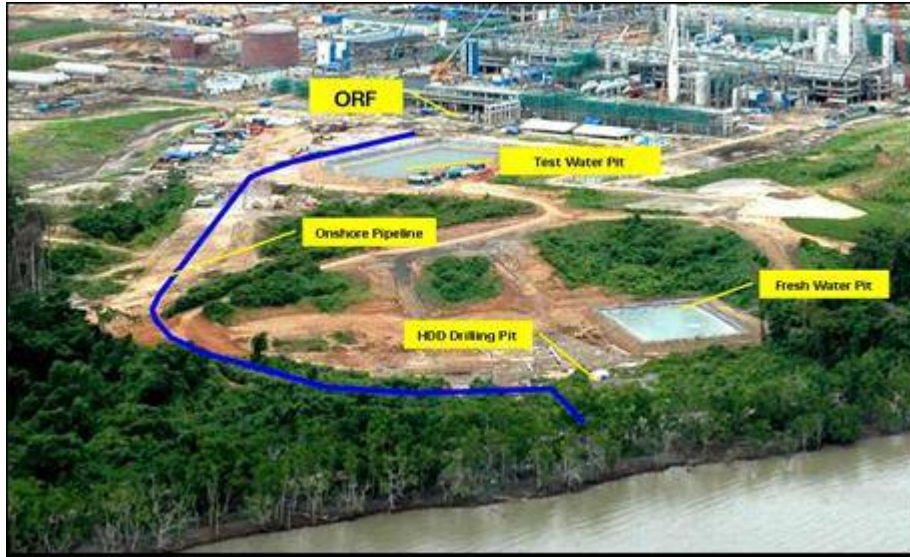
Onshore Pipeline

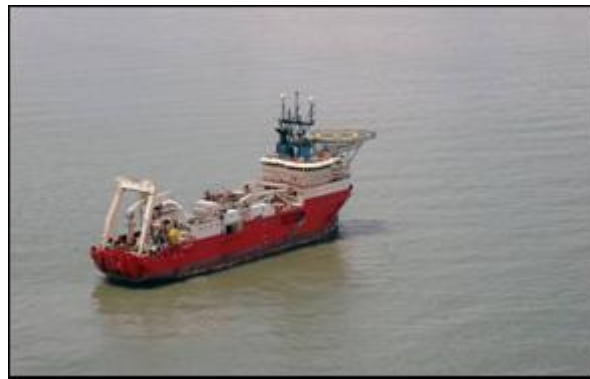
Subsea cables for power, instrument and telecommunication from the platforms to shore has been installed while the onshore section is still in progress.

VR-A Cable Installation – Fu Hai

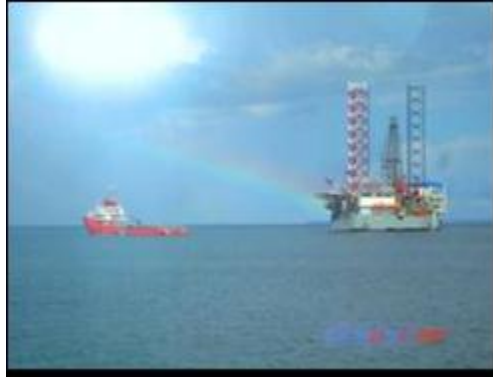
Enasco 108

The first of the two drilling rigs, the ENSCO 108, has been constructed and fitted out for Tangguh drilling operations. The rig sailed from Singapore to Bintuni Bay on 26st April and arrived on Tangguh site on 17th May 2007. Drilling of the first well is scheduled to commence before the end of May 2007. Preparation work to support drilling activities continued throughout the reporting period. Key service contracts have been placed and well casing has been delivered to the Shore Base. The Bulk Liquid Mud Plant (“BLMP”) which will be operated by Halliburton has been erected at the end of the Combo Dock. This facility will mix all of the drilling mud prior to transportation to the rig for drilling operations.

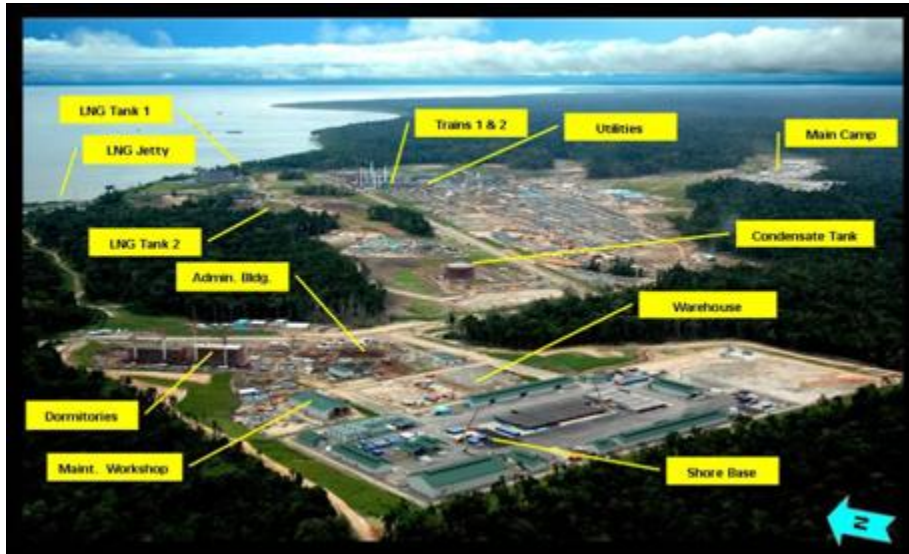
Tangguh LNG Facilities Overview

Work on the LNG Plant and supporting facilities commenced in February 2005. At the end of April 2007 the project is on schedule with overall progress standing at 77.5% complete.

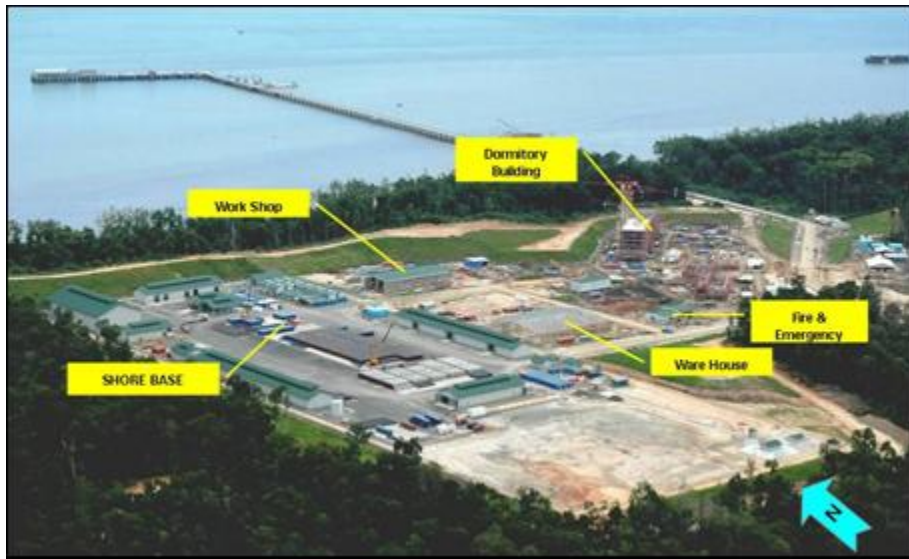
The Tangguh Shore Base (“TSB”) facility is operating and is being utilised to support the drilling programme. The activities at TSB include warehousing and storage of drilling materials, including chemicals and base fluids for drilling mud. The Bulk Liquid Mud Plant (BMLP) is currently under construction at the end of the Combo Dock with target for completion prior to commencement of drilling operations in May 2007.

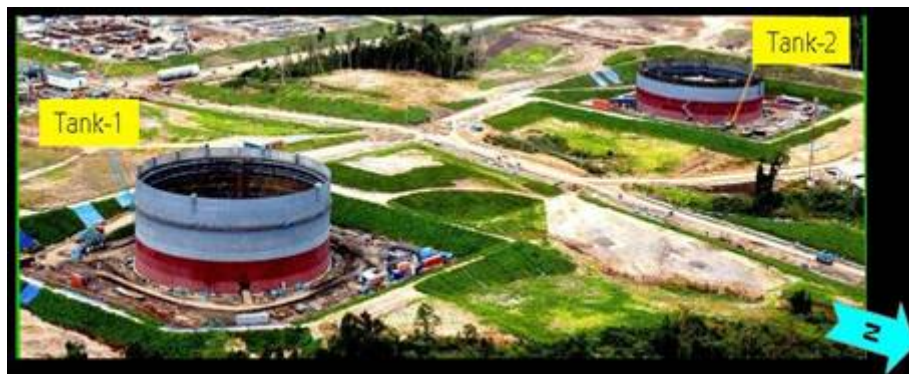
Erection of the shell plate and welding work continues for both LNG Tanks. The eight course of the inner wall and seventh course on the outer wall are under construction on Tank 1. Roof fabrication is complete. The overall progress of the LNG Tank 1 erection is approximately 60%. The fifth course of the inner and outer walls is under construction on Tank 2. The roof fabrication is approaching completion. The overall progress of the LNG Tank 2 erection is approximately 45%.

LNG Tank 1 and Tank 2

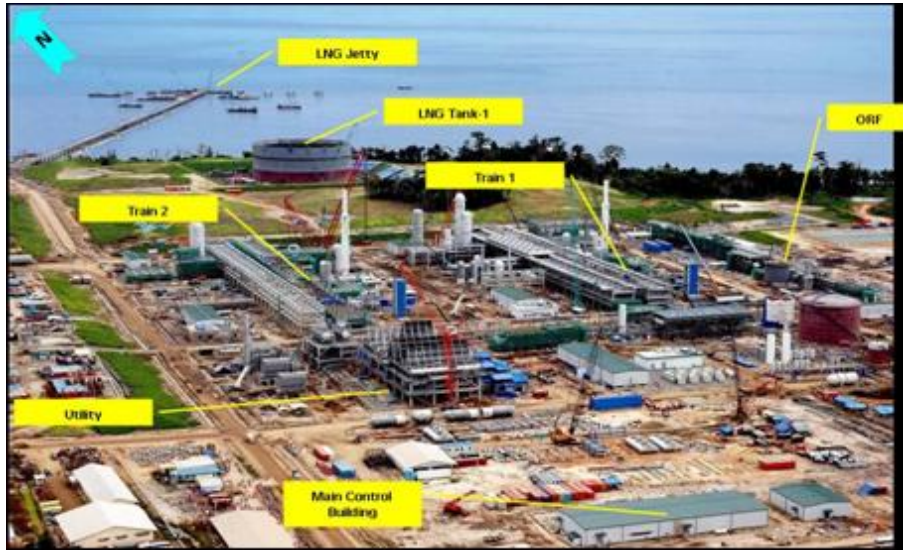
LNG Train 1, 2, ORF and Utility Area

Erection of equipment for Train 1, Train 2, ORF and the Utility areas is ongoing. Electrical and mechanical work is also in progress including cable installation for power and instrumentation, piping installation and welding, etc.

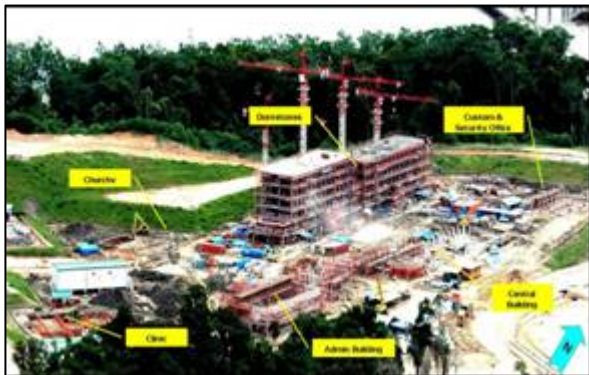
Dormitories and Admin Building

The civil work on Dormitory and Administration building area is ongoing with pre-cast concrete beam installation, form work and brick wall installation. Mechanical, electrical as well as plumbing work is also in progress in both dormitories. Construction on other areas such as BOG, condensate tank, warehouse, and workshop is progressing well.

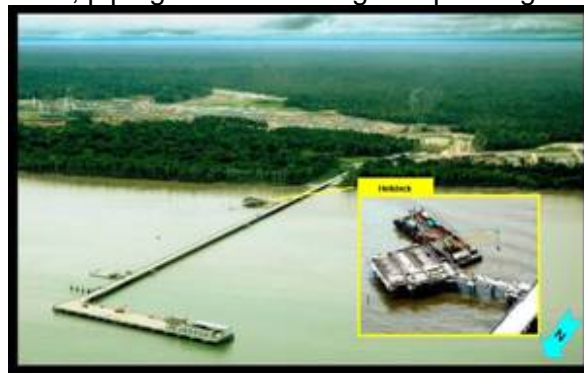
The Combo Dock is fully operational for loading and unloading work and is servicing both Shore Base and LNG construction activities. Remaining works include completion of the helideck construction, piping commissioning and painting.

Combo Dock

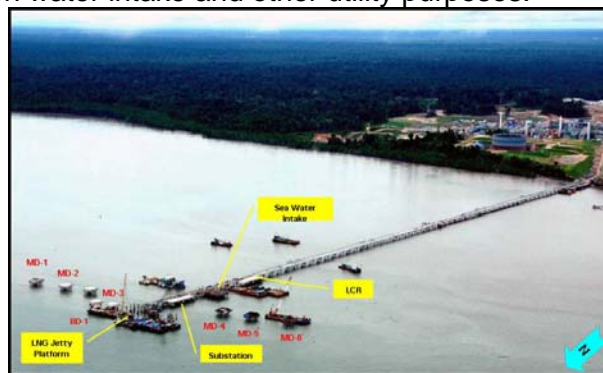
Piling for LNG Jetty has been completed. Major structural work continues and is more than 70% complete. Piping installation has commenced out from the shore and includes the LNG product lines from the LNG tanks to the ship loading arms as well as piping for firewater, desalination water intake and other utility purposes.

LNG Jetty

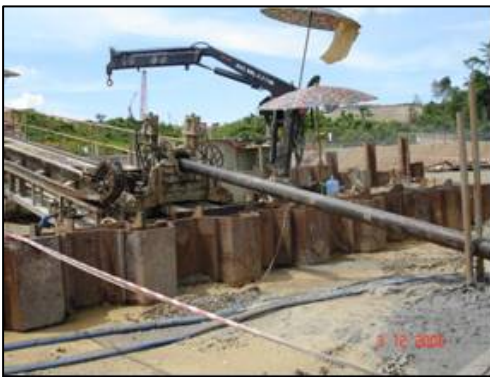
HDD Activities

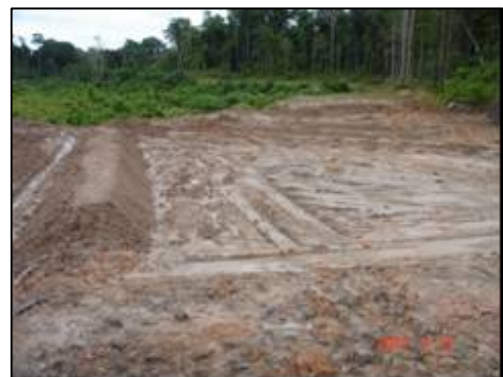
Saipem manages the waste generated from their activities and as agreed in the EPC Contract, they dispose the waste to KJP's waste treatment facility. The HDD work was completed in March 2007. There was about 450 m³ of mud generated from HDD activities. LC-50 test was performed to prove that the water based mud from the HDD is classified as non hazardous waste so as per the MOE permit it can be disposed to the mud landfill located next to KJP non hazardous waste landfill area.

HDD Mud Landfill

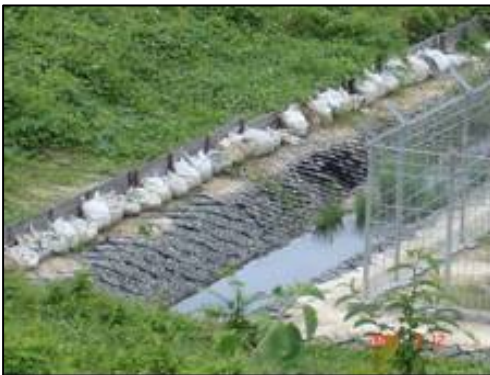
Temporary and permanent drainage systems have been constructed to direct the stormwater to its natural path. Sediment ponds completed with brush barriers constructed from leaves, branches and unsuitable non commercial timber (biomass) were installed to prevent sediment flow into the rivers or creeks.

Permanent Drainage at the Shore Base Area

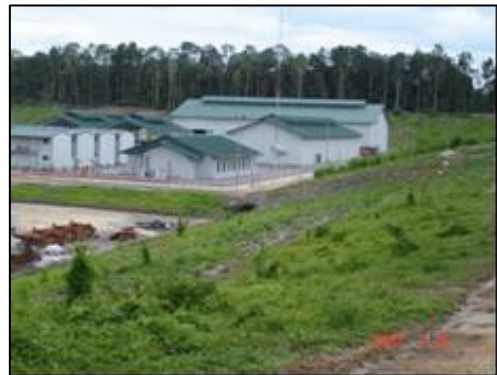
Erosion Control and Land Stabilisation at the Shore Base area

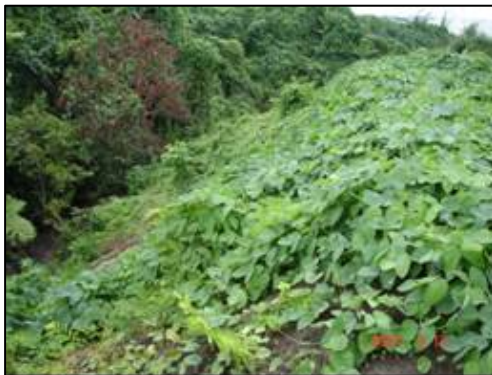
In our last report we noted that earthworks in the Boil-Off Gas area resulted in spoil disposal into a nearby creek which is considered as sacred creek by local community. KJP has since removed the spoil and debris from the creek and has planted a cover crop to prevent soil sliding and erosion. The creek is not part of the construction footprint and is a natural drainage to direct run off flow to the sea. No further erosion or sliding has been observed at this creek.

Sacred Creek Slope Protection

A re-vegetation plan has been completed by KJP. The next step is to select a subcontractor to implement the plan including the establishment of a nursery to support the re-vegetation operation. It is expected that the programme can be started by the end of 2007.

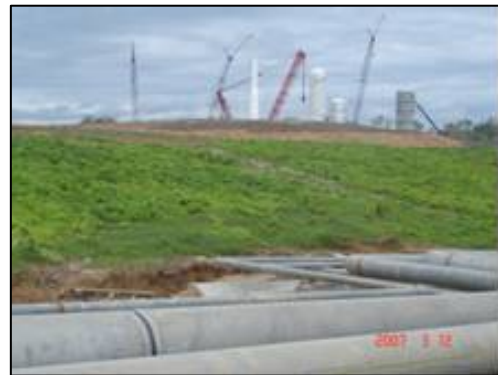
Slope Protection on the Road to Jetty

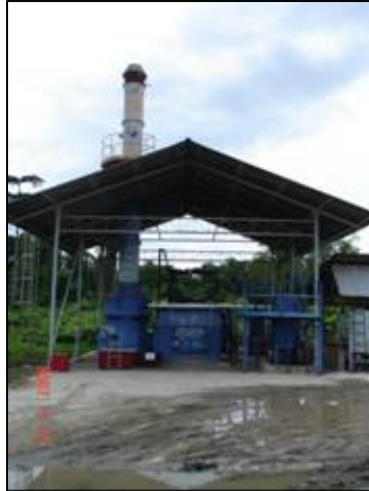
1. **Hazardous waste** (used oil, oil filters, paint cans, batteries, oily rags, aerosol cans, contaminated soil/materials, etc). The waste is delivered to Central Waste Accumulation Area #1 (CWAA) in the Step 1 area and stored in the temporary hazardous waste storage. It is transported regularly to the certified hazardous waste facility (PPLI) at Bogor. The burnable hazardous waste e.g. oil rags and some used oil is delivered to the hazardous waste incinerator located next to the temporary hazardous storage. KJP obtained a permit from the Minister of Environment through the Minister Decree No B-7559/Dep IV-4/LH/11/2006 dated 10 November 2006 for the operation of Temporary Hazardous Waste Storage. KJP has secured the Minister of Environment Decree No B-1408/Dep IV-4/LH/02/2007 dated 26 February 2007 to authorise the operation of the Hazardous Waste Incinerator.

Hazardous Waste Incinerator

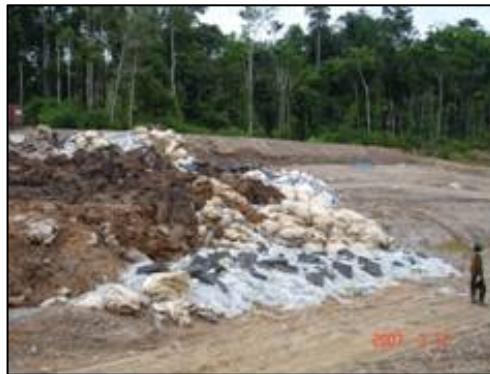
2. **Landfillable waste** (damaged cement bags, rock wool, styrofoam boards, small scrap metal & cables, asphalt drums, HDPE-sheets). This waste, estimated at an average of about 350m³ per month, is disposed in the non hazardous waste landfill areas (2 x 9,000m³).

Landfill for Inert and Non Hazardous Waste

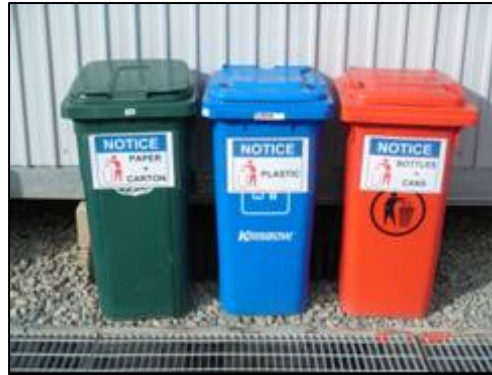
3. **Reusable waste**, such as, used tires, large scrap metal-spools, pipe cut-offs, cable, timber is transported to Central Waste Accumulation Area (CWAA) 2 located next to non hazardous waste incinerator. This waste is available to any subcontractor that may wish to use it.
4. **Re-cycleable waste**, such as, food/drink cans, plastic bottles, glass bottles cardboard/carton is stored in a container next to construction jetty for regular shipment to the non hazardous waste collector at Sorong. Recycling of these wastes is performed to some extent in this facility. A total of 6 containers (225.5m³) were sent to the recycler on the 5th and 16th March 2007.

Waste Segregation

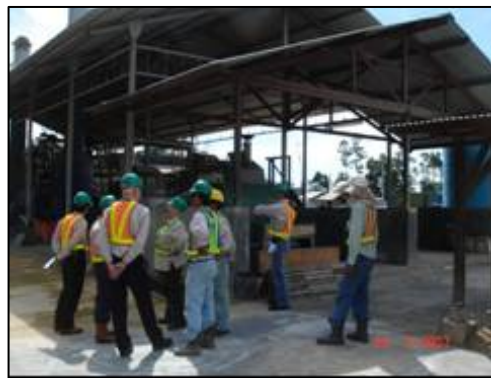
5. **Food waste** – Average monthly food waste of about 100m³ is deposited into a clay-based waste pit. KJP has installed 12 drain sinks and two food waste extractors. Only one food waste extractor is currently operational. The food waste extractors are expected to reduce the volume of food waste going into the pit by about 80%. The mulch produced will be incinerated or composted and used for soil improvement. However, some amount of food waste (meat and fats) cannot be composted and will continue to be dumped into the waste pit.
6. **Combustible waste** (paper, carton, wood chips etc) is transported to non hazardous waste incinerator for burning. There is about 180 tons/month of combustible waste burnt in the incinerator.

Non Hazardous Waste Incinerators
