Environmental Monitoring Report
Project Number: 30232
May 2010

NEP: Decentralized Rural Infrastructure and Livelihoods Project

Environmental Monitoring Report
For
DRILP

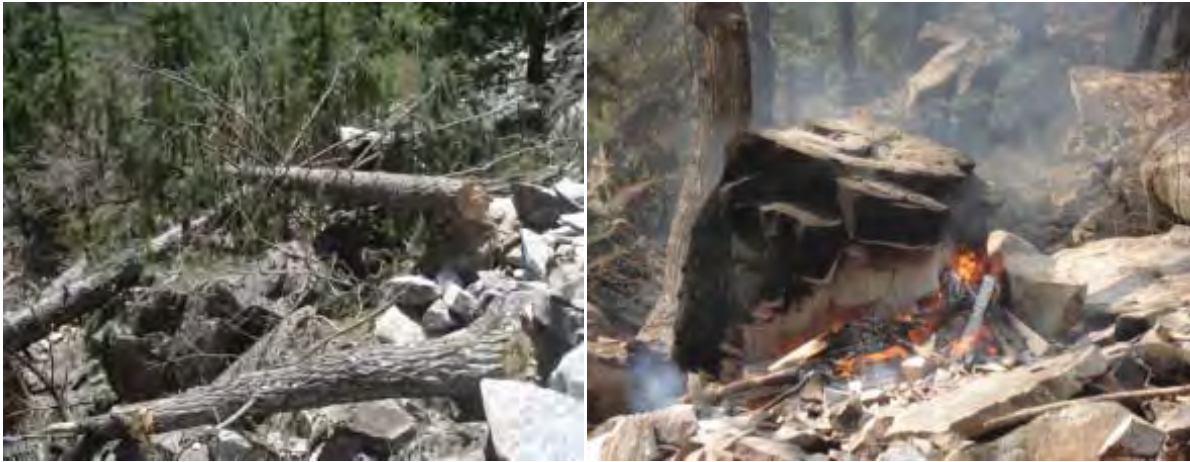
Use of Trees for Breaking Boulders in Humla

Sallikhola-Tumkot 22.15 km long road in Humla district of Karnali zone is under construction. This road mainly passes through forest area (60%). People's movement is limited in winter due to harsh climatic condition and snow fall in most of the area. The vegetation type of the project area is temperate coniferous forest with blue pine (*Pinus wallichiana*) as dominant species.

This road is being constructed by applying labor based environment friendly and participatory (LEP) approach. Most of the area is characterized by the presence of high volume of boulders which are very difficult to break manually with simple tools. Along Foreskhargen community forest area, workers are using traditional heating and splitting method for breaking boulders which was practiced in Great Britain during mid 1600 AD. This method is being used due to the lack of hydraulic rock splitter and portable drilling machine. Though District Development Committee (DDC) is ready to provide these equipments, these equipments have not yet reached at work site. This is creating high pressure along the adjoining forests. Lots of trees have been cut indiscriminately by the workers for breaking the boulders by heating. This will ultimately result in the loss of biodiversity, occurrence of fresh landslide and acceleration of erosion along the road alignment. Consequently, sustainability of Sallikhola-Tumkot road will also be affected.

This is a serious issue and needs immediate attention from the DDC. Necessary equipments like hydraulic rock splitter and portable drilling machine should be provided at the site as soon as possible and workers and DISC staff should be oriented about the conservation of forests. Moreover, coordination with District Forest Office (DFO) should be initiated.

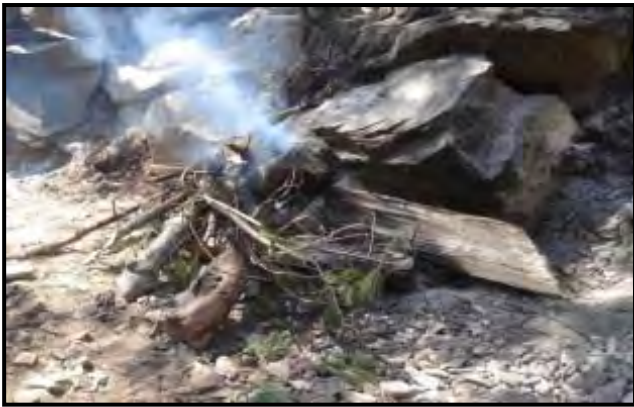
Stone breaking through the wood firing at Humla

- Lack of timely procurement of necessary equipments like, hydraulic rock splitter and portable drilling machine has adverse impact as trees are being used for breaking boulders. Consequently there will be depletion of the forest vegetation along the road alignment.

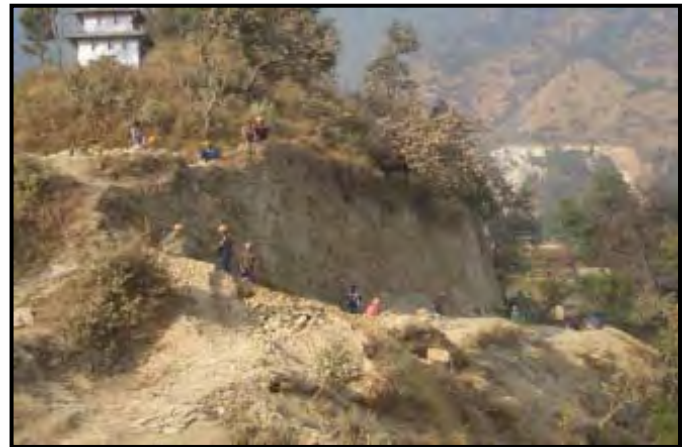
Workers are using helmets during stone cutting

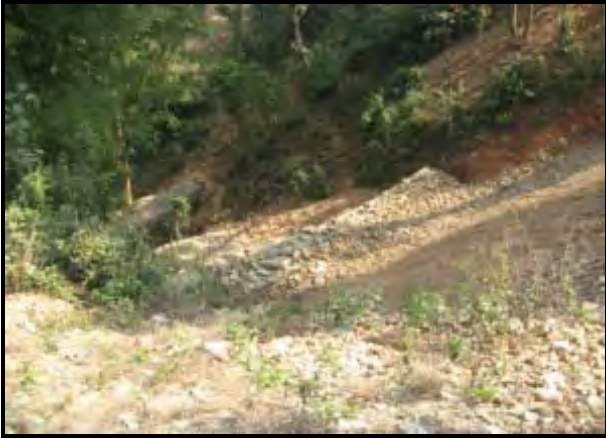
Toe wall to check spoil disposal in Ramechhap

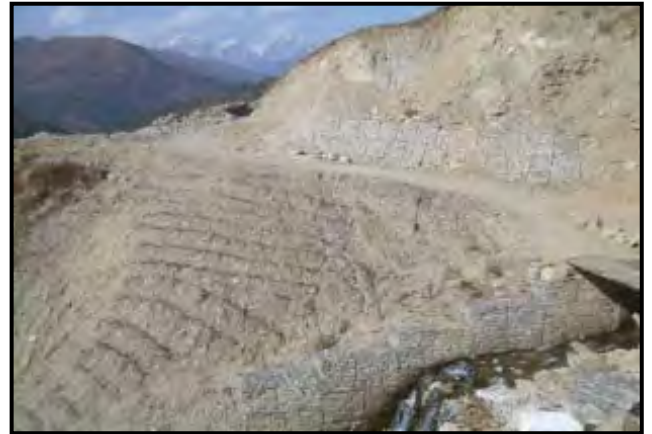
Bio-engineering works at Okhaldhunga

16. Bioengineering measures are adopted in some of the road alignments like Phaphlu-Jantardhap and Okhaldhunga-Jantardhap road sub-projects at various chainages (see **Annex V**). In other road sub-projects, survey and estimate has been completed for bioengineering activities (Darchula, Baglung, Baitadi, Myagdi, Bajhang, Ramechhap districts). However, in some other districts, survey and estimate for bioengineering activities has not started yet. It is reported that minimum damage to vegetation has been ensured and minimal numbers of trees have been cut to protect the slopes. Nursery establishment has not been done.

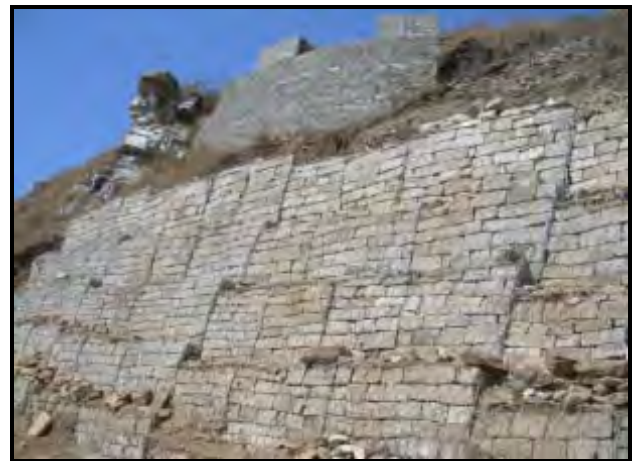
Gabion wall construction in Okhaldhunga

15. Construction approach was found to be supportive to minimize land slide and erosion. Usually road construction works have been stopped during rainy season to minimize landslide and soil erosion. There are minor landslides along the road sub-projects which are primarily passive in nature except Salme landslide along Phaphlu-Jantardhap road which has been now completely rehabilitated. Retaining walls have been constructed to maintain slopes. Gabion structures seem stable for the protection of slopes.

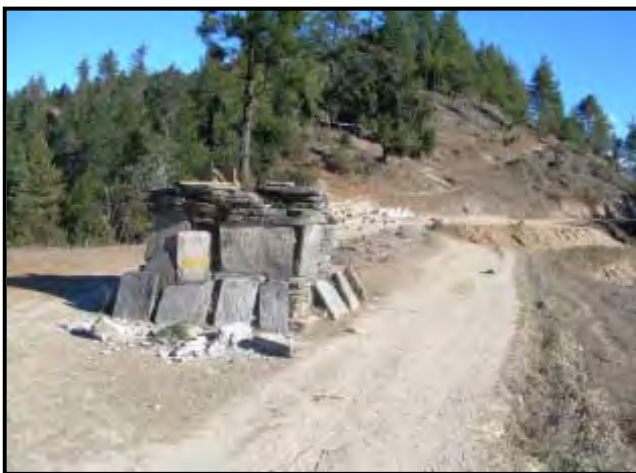
Mane before road construction (Solukhumbhu)

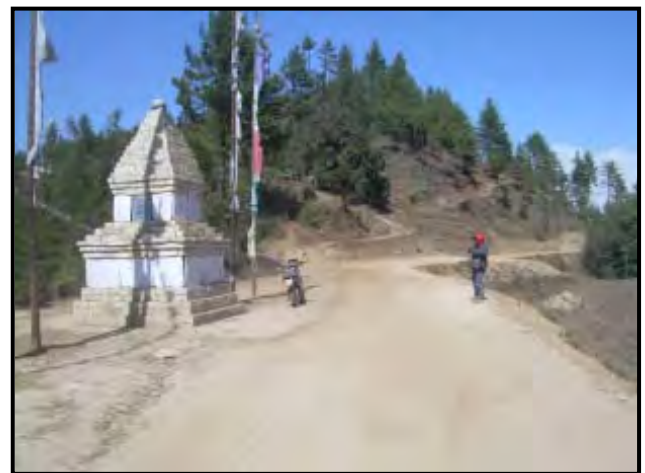
Mane after road construction (Solukhumbhu)

31. Mainly temples and manes (Buddhist temple) have been affected due to road construction as they fall in the road alignment. Pathapale temple in Bajhang and Thati temple in Ramechhap have been shifted in consultation with local people. Likewise, Setomane (Buddhist temple) in Solukhumbu has been rehabilitated and two mane in Okhaldhunga have been relocated in consultation with local people
